**FIRE STATION PLACEMENT
REVIEW AND CONSIDERATIONS
FOR
EMPIRE TOWNSHIP**

The purpose of this assessment of the is to analyze the positive and negative features of Glen Lake Fire Station # 2 sited at 11530 Lacore Road, Empire, MI.

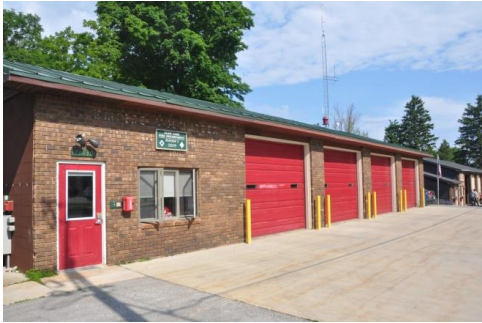
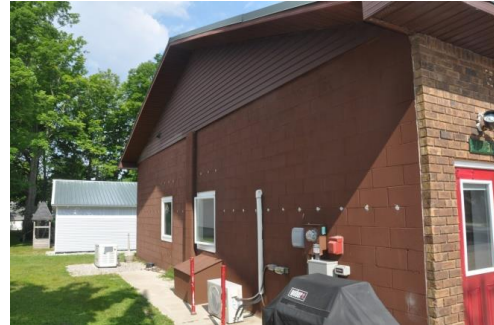
FIGURE 13 - EXTERIOR VIEW OF STATION 2

Station 2 seems to be structurally sound and in good condition and would be better suited for a small equipment shed or other small demand uses.

Concrete block with a brick façade on the front side of the building only; a concrete slab with a wood framed, pitched roof structure with a standing seam metal roof which was repaired in 2014.

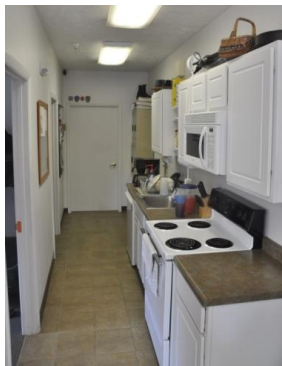
FIGURE 15 – KITCHEN AREA

The entire crew living area consists of a galley kitchen, dayroom/workspace, two (2) bedrooms, one bathroom, one laundry/shower area comprising approximately 450 square feet.

It was renovated in 2008 with typical residential finishes. Some of the original light fixtures, door closers and other items were re-installed when the construction was done. These finishes and hardware do not withstand constant use well. The area is very cramped. Fixtures need repair often.

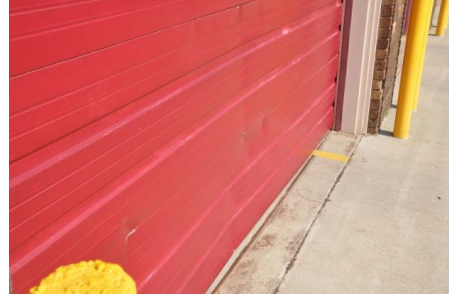
FIGURE 20 - EXTERIOR VIEW OF BAY DOOR

They are showing their age and have many dents and dings. The door opener remotes do not work anymore. Service on them can be a struggle.

The doors are ten (10) feet tall. This door height is inadequate to move heavy trucks in and out. It is limiting the design of new apparatus and housing existing apparatus,

The garage doors have many dings and dents from a long service life. They have required frequent maintenance to maintain their operability. The garage door openers are very old and need replaced.

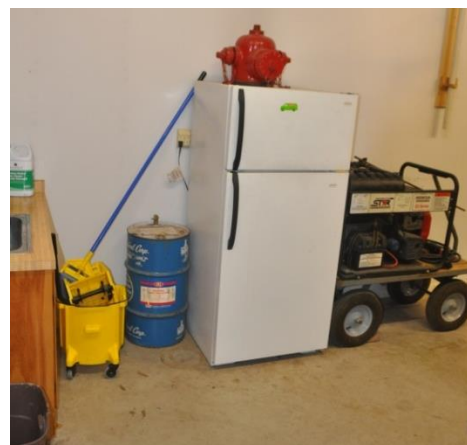
FIGURE 24 – STAFF REFRIGERATOR IN BAY

There is a residential kitchen sink and cabinets that were not removed when the building was renovated. There is also a 21 ft³ small full-size refrigerator in the bay as there is no room in the kitchen for it. The crew must use this unit for overflow storage because the small built-in unit is insufficient for regular use by multiple personnel.

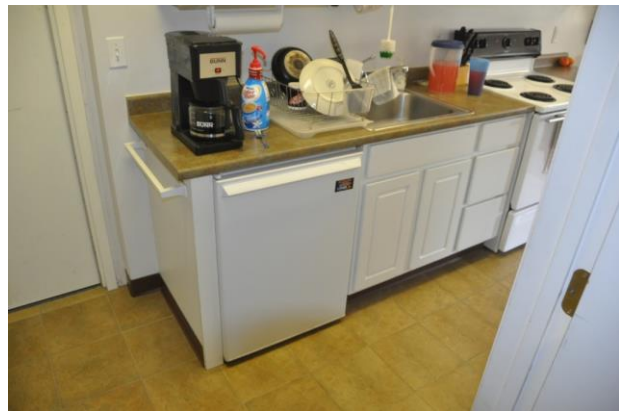
FIGURE 25 -VIEW OF KITCHEN AREA FROM BEDROOM

The kitchen has an electric stove, microwave, and a college dorm style refrigerator. It does not have a dishwasher. The residential laminate counter tops and cabinets are showing a lot of wear. Dishes constantly must be washed in the sink leaving water on the counters. A dishwasher was talked about but the refrigerator would have to be removed to install one.

The finishes such as cabinets, counter tops, interior doors were an average residential type to begin with and they cannot take the long-term wear and tear. No entry way into the main area which causes a lot of dirt/snow to get tracked in.

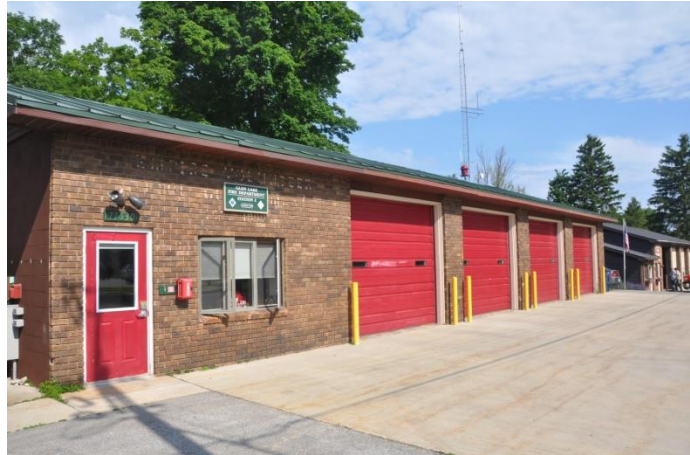
FIGURE 26 - EXTERIOR VIEW OF STATION 2

The road side of the building has a brick façade over concrete block. Many of the bricks are chipped and in need of repair.

The soffit and fascia were not replaced when the roof was replaced. It is dented in many areas and the finish is peeling off.

The metal roof is in good condition because it was repaired in 2014. The snow slides off the roof and deposits in front of the garage doors. If not cleared immediately, trucks traffic will compact it into a block of ice. This causes the truck to ride up and, potentially, hit the jamb and damage the building. Careful, and intensive, maintenance has avoided that thus far.

The window on the front of the building was not replaced when the renovation was done. It needs to be replaced.
