LELAND DAM INSPECTION

Dam Identification No.: 510
Hazard Potential: High
NE Quarter of Section 9, T. 30 N. – R.12 W
Leelanau County, Michigan
Lake Leelanau

Date of Inspection: September 1, 2022
Date of Report: October 2022

Project I.D. Number 131999SG2022

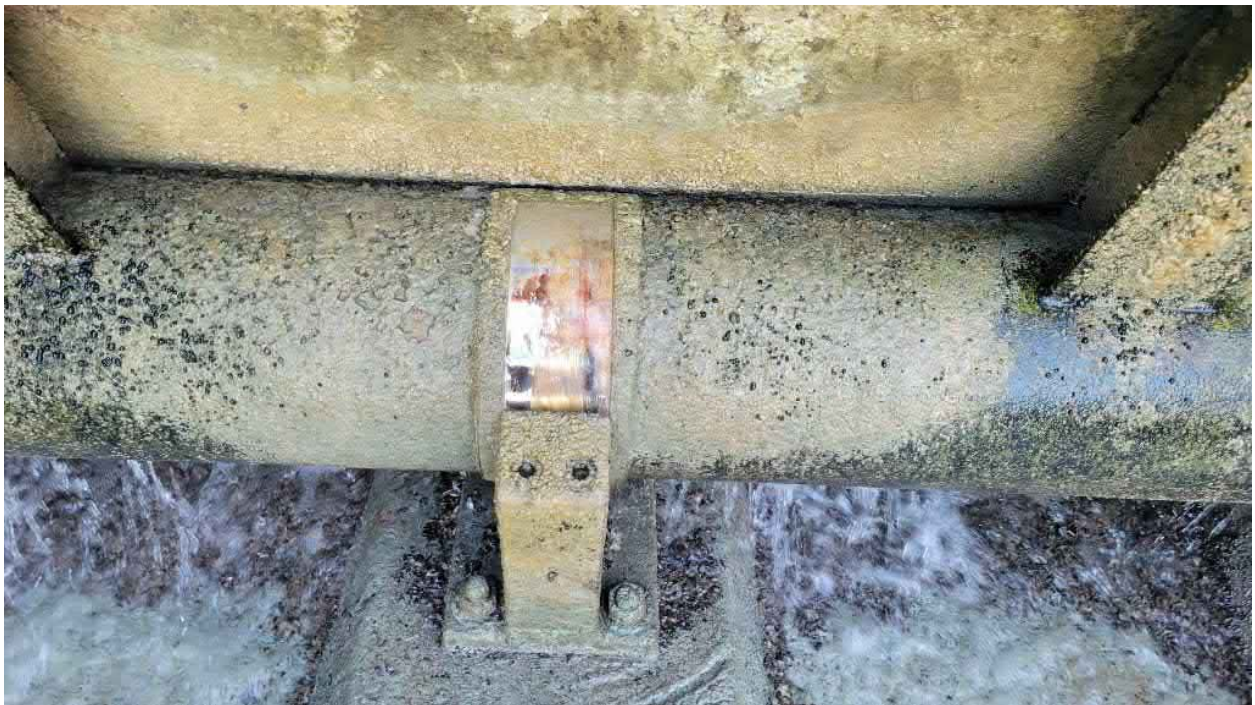
Joint Observation - Corrosion

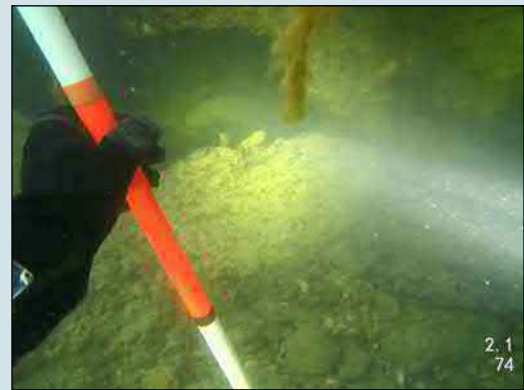
Pier #3 consists of a variable height wall cast on the spillway slab. The wall above the slab has been rehabilitated and is in good condition. The wall serves as the south wall of the machine room. At the downstream end here is a scour wall underwater directly below Pier #3 that intersects the downstream cutoff wall and extends to the end of the spillway. There is an additional scour wall separated by a gap that continues downstream. Both of these scour walls have scale throughout their surface and spalls at the top corners adjacent to the gap between the walls. There is a gap between the slab and the top of the scour wall under the spillway overhang.

Pier #3 downstream end

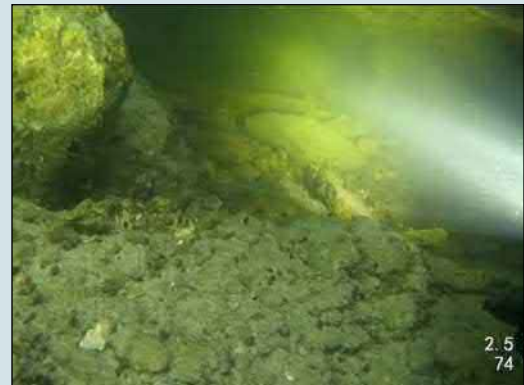
There is a section steel of sheet wall upstream of the right abutment that is in good condition with surface rust above the waterline. It is coated with a chalky sediment up to 1/2" thick. The steel sheeting is in good condition where the sediment was removed.

Cutoff wall and right abutment

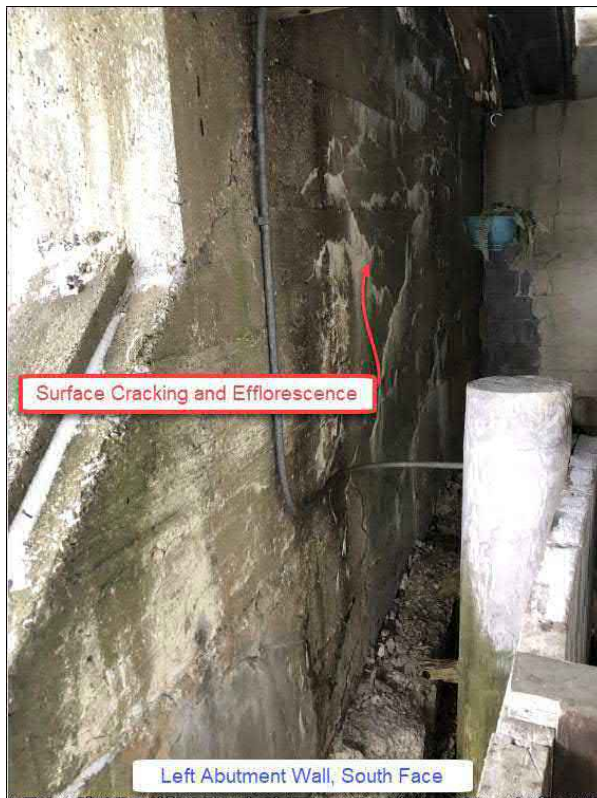
The south face (Lodge Side) of the left abutment exhibited surface cracking and efflorescence. This cracking appeared to be only surface defects and the wall is in sound condition.

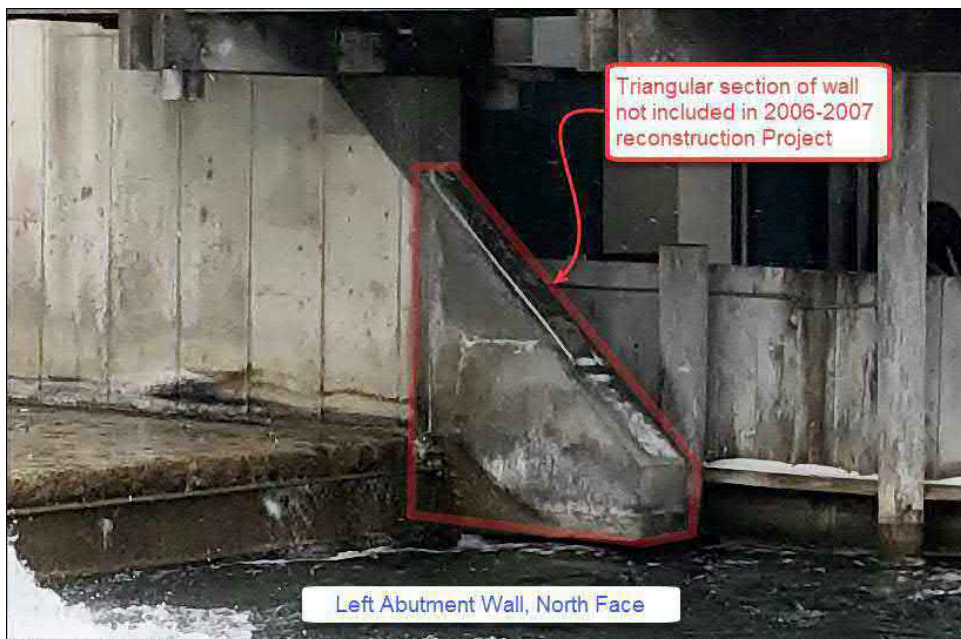
There is a section of the wall that is perched over the downstream end of the spillway. This portion of the wall did not have repairs completed during 2006-2007 rehab project. This portion of the wall appears to be in sound condition with minor cracking on both the north and south faces. There were areas observed near the waterline and below that may exhibit deterioration. This area could not be inspected during this site visit and would require a diver to further investigate the overall condition.

During the meeting anticipated repairs and the methods needed to complete these repairs were discussed. Anticipated repairs included minor concrete surface patching to the south side of the left abutment wall. In addition, there may be repairs required along the downstream side of the spillway near the perched end of the left abutment which may include sheet piling, underpinning, and concrete fill.
