ELECTRONIC SENSOR CALIBRATION

February 14, 2024 Gauge Readings and Comparisons at the Dam and Narrows

HISTORIC ELECTRONIC SENSOR READINGS

ONE MONTH STARTING JANUARY 24, 2024

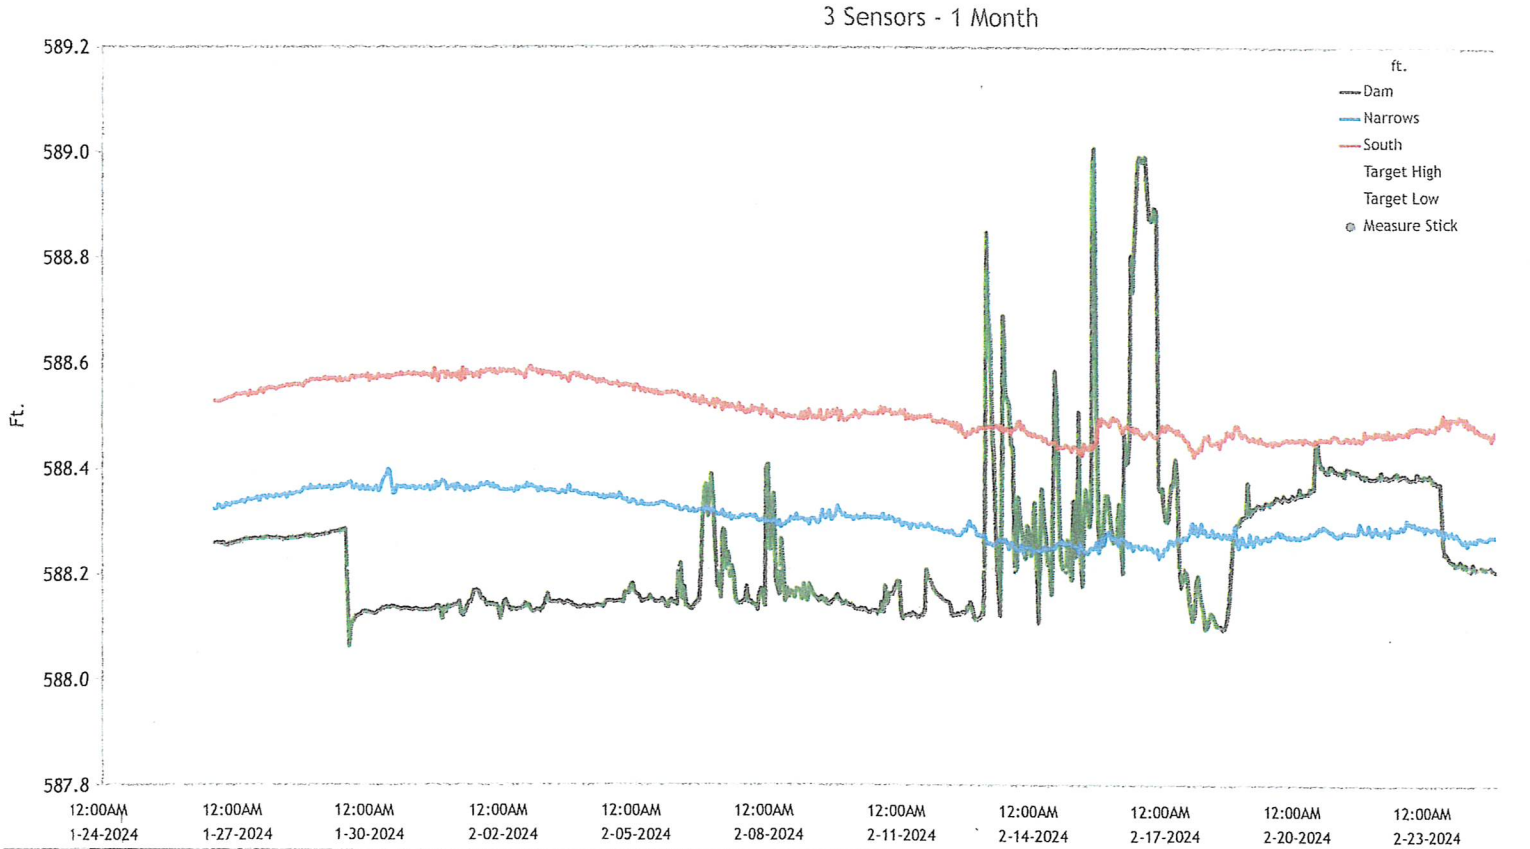
Graph: 3 Sensor 1 Month

- 1) The narrows readings continue to correlate with its respective staff gauge.
- 2) The south lake readings continue to correlate with its respective staff gauge.
- 3) The electronic sensor at the dam started to behave erratically starting February 6th through the 8th and again later in the month.
- 4) The chart below shows the readings.
- 5) John Popa to describe the investigation
- 6) Suggested action to repair the dam sensor — — — Purchase a new sensor and install as soon as it's available.
