**Operations Management
and Facilities Services**
2021 Annual Report

Northport Leelanau Township Utilities Authority Wastewater Treatment Plant

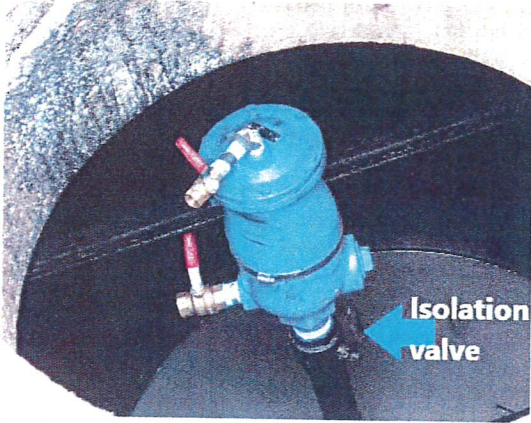
Maintenance item	Description of action taken	Benefit
Collection system	<p>We completed the annual air release valve (ARV) inspections. The West Street ARV was the only location found in need of cleaning. Grease and debris were removed from the float chamber before returning it to service. The remaining locations, with the exception of the ARV at Northport Point Road, west near Woolsey Lake Road, were found to be in good working condition. The isolation valve handles for the ARVs at Northport Point Road west near Woolsey Lake Road, and East Paradesia Road, are severely corroded and currently inoperable. Jacobs recommends replacing the valve handles with 316 stainless steel or equivalent.</p>	<p>Inspecting the ARV valves on a regular schedule helps to identify and plan for maintenance needs and reduces the possibility of issues arising as a result of equipment failure.</p>

<p>Paradesia Road – isolation valve needs replaced.</p>

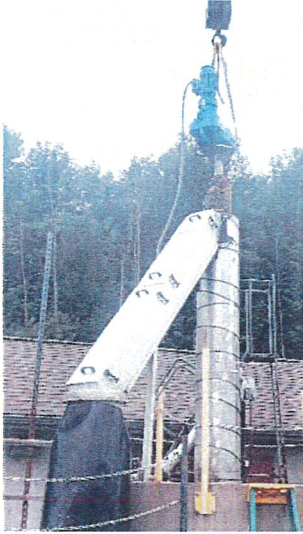
Fine screen unit maintenance: Incoming flow enters the facility through the lower portion of the fine screen unit, screening debris larger than 1/4" from the waste stream. The fine screen unit contains brushes that, when rotated by the auger, keep the screen clean. We inspect the brushes and replace them proactively before they no longer effectively clean the screen. In 2021, we performed a brush replacement. During replacement we also inspected the fine screen wear bars, hardware and the integrity of the auger itself. We found them to be in good working order. Note: In 2014 we noticed significant pitting on the auger body, which prompted us to have the auger coated with an epoxy coating to extend its useful life.

Fine screen auger removal by crane.

When fine screen brushes begin to wear, they no longer effectively clean the screen causing the flow to automatically bypass the screening process, allowing debris in the waste stream to bypass and eventually cause issues with downstream moving bed biofilm reactor (MBBR) equipment. Proactively replacing the brushes prevents this from occurring.

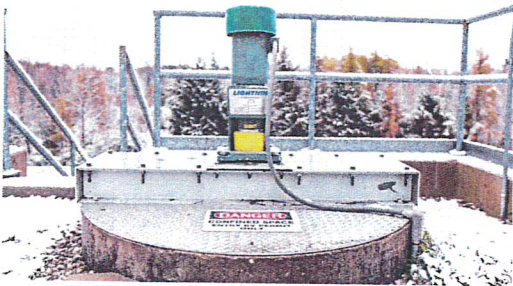
<p>Rebuilt and reinstalled floc mixer.</p>	<p>The mixer is used to keep solids suspended in the waste stream and, when feeding ferric chloride at this location, it also ensures the ferric chloride is mixed homogeneously throughout the waste stream for optimum removal of phosphorus.</p>

Maintenance item	Description of action taken	Benefit
Treatment plant	<p>2021 capital improvement project: Kaeser blower replacement. A new Kaeser blower was installed in place of failed blower #1. Blower #1 failed under warranty. Jacobs and the Village are working with Kaeser to recoup the costs. Blower #2 is available for redundancy.</p>	<p>The blowers provide air (oxygen) to the MBBR. The microorganisms in the MBBR need this air to metabolize pollutants in the waste stream. Without the proper addition of air (oxygen) to the basin, the plant will fail to effectively treat the waste stream and possibly meet the requirements of its discharge permit.</p>
	<p>Floc mixer #2, next to the upper sand filter, was rebuilt and placed back in service.</p>

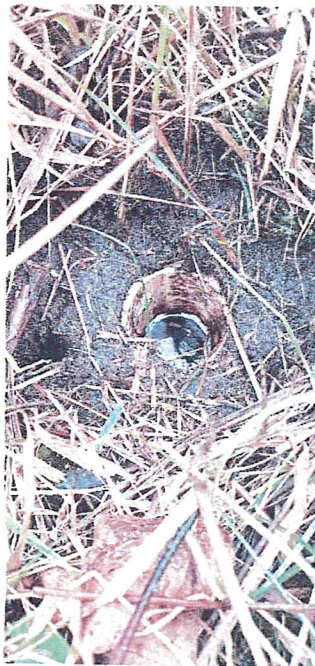
During our quarterly monitoring well sampling event in August, we discovered the well casing pipe for monitoring well 13 was broken, preventing us from sampling. We repaired the well casing pipe. We notified EGLE of the repair and informed them the missed annual sampling from August would be included in the November sampling event.

Broken well casing pipe.

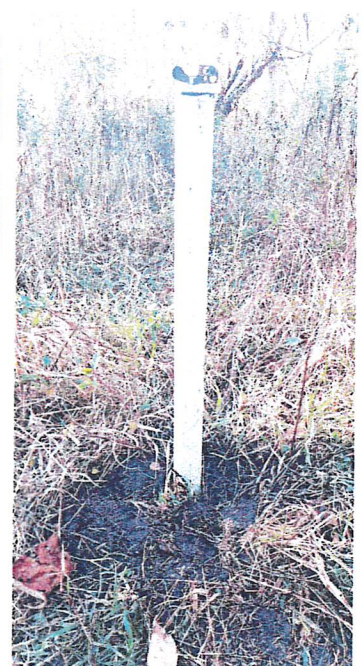
Repaired well casing pipe.

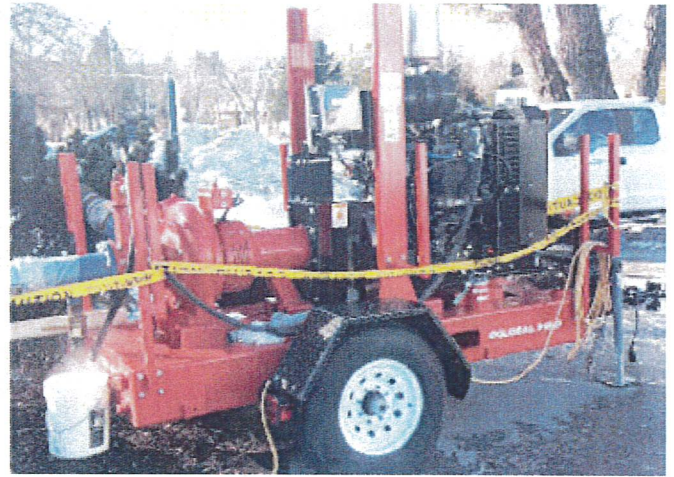
On December 11, we responded to a main lift station pump 1 failure alarm (pump 2 previously failed on October 29). Pump 1 was originally installed in 2018. We confirmed the pump was unable to operate, which left the station without either submersible pump available.

Main lift station bypass pumping.

As dictated by our emergency response plan, we set up a second bypass pump at the lift station. The first bypass pump was set up when pump 2 failed; we scheduled a 24/7 pump watch to ensure the continuity of pump operations and wastewater conveyance to the treatment plant. With neither pump 1 nor 2 repairable, to regain pumping capabilities as expeditiously as possible, Jacobs consulted with Kerr Pump's repair team to see if the two failed pumps might be used to build one operable pump.

Kerr provided us with one operable pump within two weeks. The pump was installed and tested on January 1, 2022. This new pump eliminated the need for 24/7 pump watch and bypass pump rental. Exhibit 6 details the estimated cost savings associated with eliminating the pump watch. The cost to combine the failed pumps was recovered within nine days of installation, resulting in continued savings of approximately \$894 per day until the new pump(s) arrived.

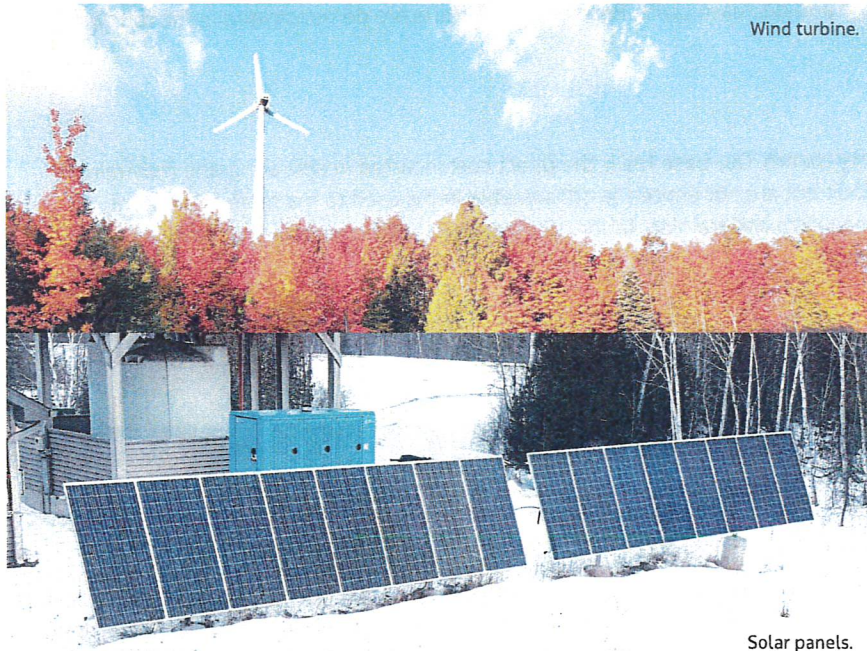
Exhibit 8
Treatment plant electrical usage summary

In 2021, the wastewater treatment plant received 20 percent of its overall energy from renewable energy sources. Wind generated electricity accounted for 67 percent of the renewable energy used at the facility, and solar generated electricity accounted for 33 percent of the renewable energy used at the facility (refer to Exhibit 9). Jacobs strives to reduce energy consumption by maintaining plant equipment, monitoring equipment run times to identify and correct issues promptly and limiting water and electrical usage (Exhibit 8) where opportunities exist. We are proud to serve a community that shares a passion for a renewable and sustainable future.
