# **FINAL REPORT**

## **South Bar Lake, Empire, MI Water Quality Monitoring**

August 25, 2014

# **South Bar Lake/ Village of Empire Water Quality Monitoring and Storm Runoff Assessment**

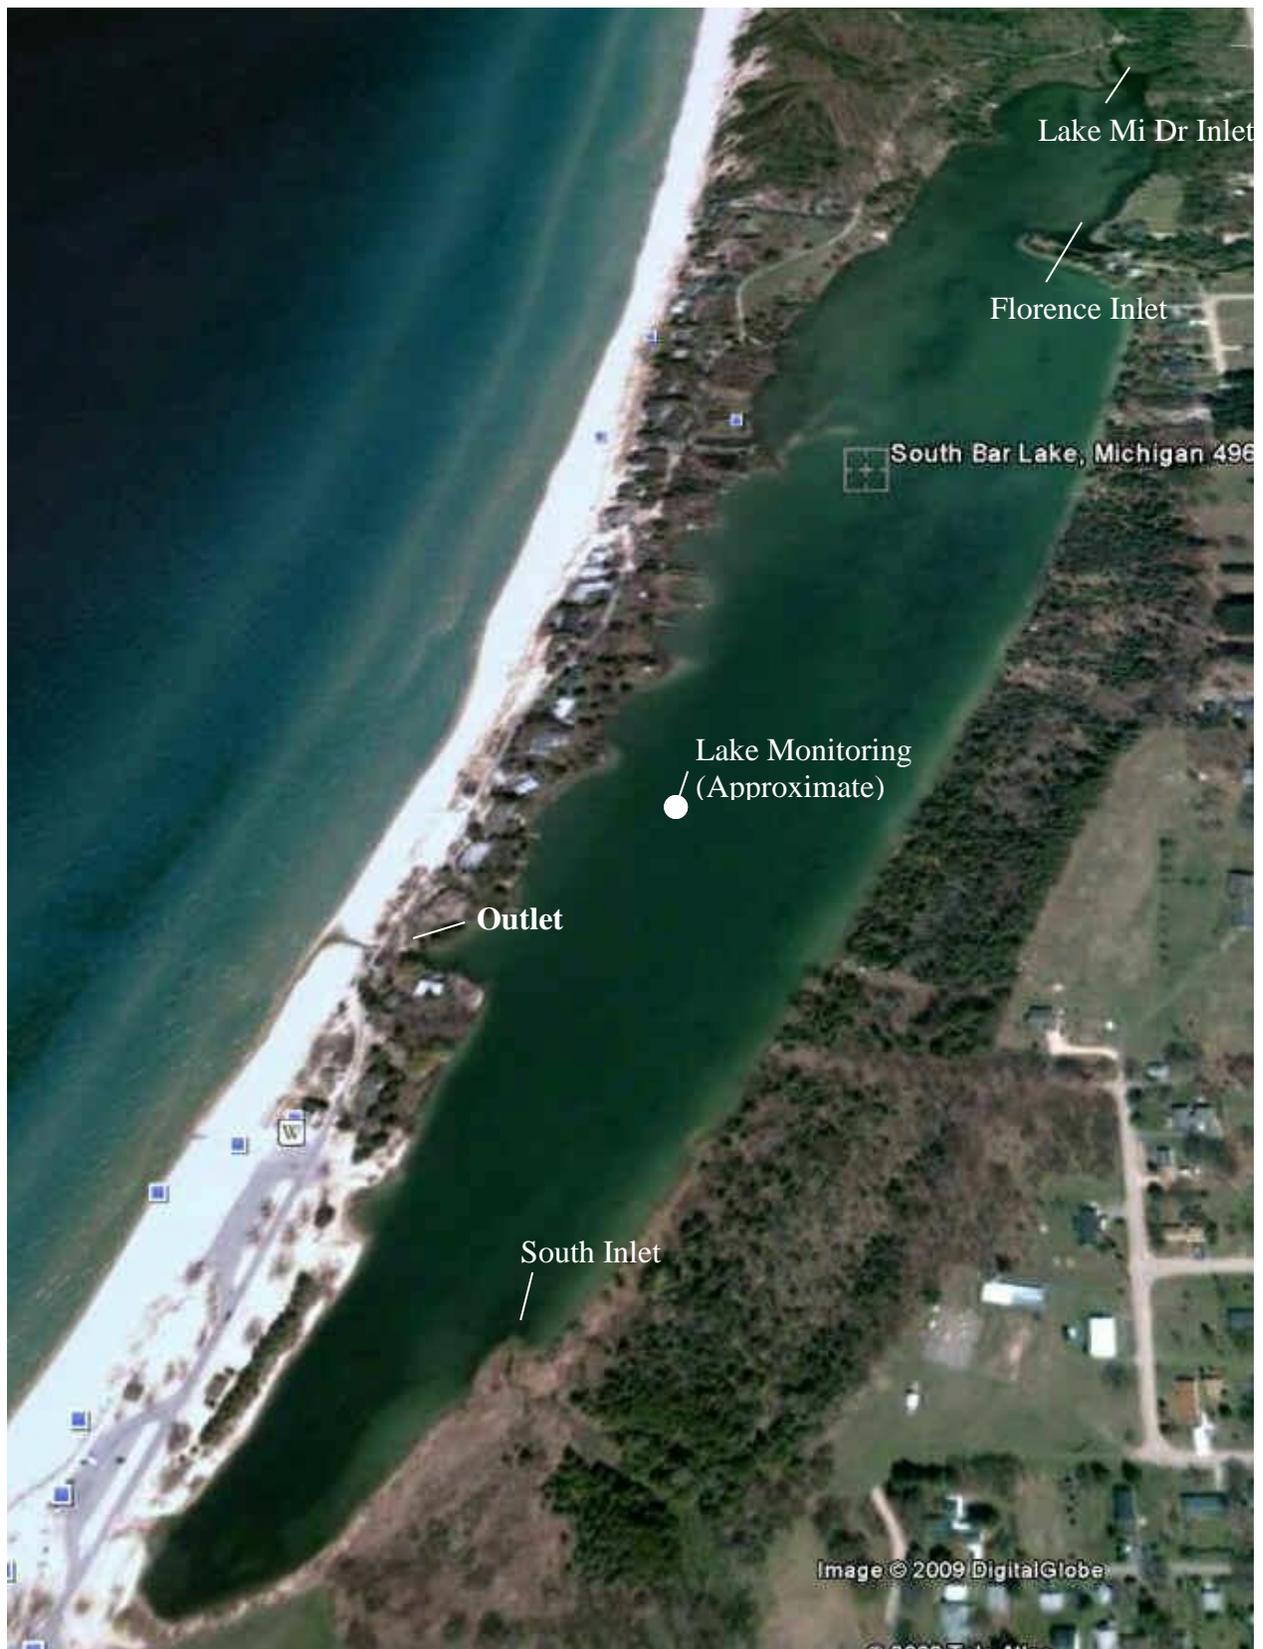
Figure 1. South Bar Lake Monitoring Sites, July 2, 2009.

**Lake Sampling.** Sampling was conducted at South Bar Lake on July 17 and October 2, 2013 as well as on May 9, 2014. The lake sampling locations for water quality measurements analysis are shown in Figure 1. Lake water samples were collected at the surface with a polypropylene sampling bottle and transferred to 0.25 L glass bottles acidified with H<sub>2</sub>SO<sub>4</sub>. These samples were analyzed for total phosphorus and nitrate/nitrite nitrogen by Great Lakes Environmental Center (GLEC) in Traverse City, MI. All nutrient samples were analyzed by GLEC using established Standard Operating Procedures (SOPs) and analytical techniques (SOPs on file at GLEC). In addition, a Hydrolab® Quanta was used to measure pH, temperature, dissolved oxygen, oxidation-reduction potential (redox) and conductivity every foot from the surface to three feet and at three foot intervals to the lake bottom, approximately 10 feet. These variables are generally accepted lake water quality parameters which can be used to assess the relative water quality of the lake.

**Tributary Monitoring.** Tributaries were monitored a three times (summer and fall in 2013, spring 2014 on same dates as lake water quality sampling) at the inlets and at the outlet of the

lake (Figure 1). The tributaries were monitored for total phosphorus and nitrate/nitrite nitrogen by collecting water samples in 0.25 L acidified glass sample bottles. In addition, flow rates at the inlets and main outlet (Figure 1) were measured by a digital flowmeter at approximately 20 equal intervals across the stream bed. The flow at each interval, and the cross sectional area were combined to provide a total cross sectional flow for the stream. This flow rate, in conjunction with the measured nutrient parameters, allow for the estimation of nutrient loading of phosphorus and nitrogen, and a total “phosphorus and nitrogen “budget” to be calculated (nutrient inflow – nutrient outflow). It should be noted that this nutrient “budget” can change daily and will change seasonally depending on local conditions, including rain events or snow melt.

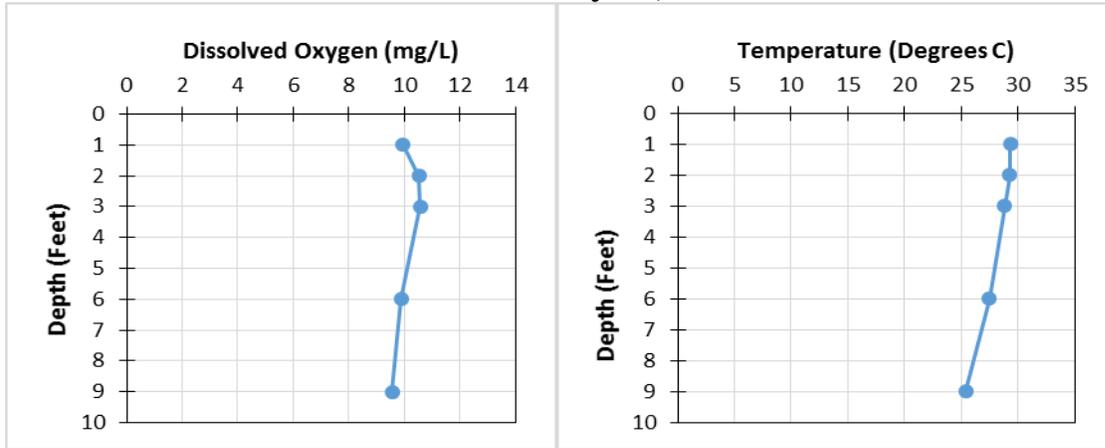
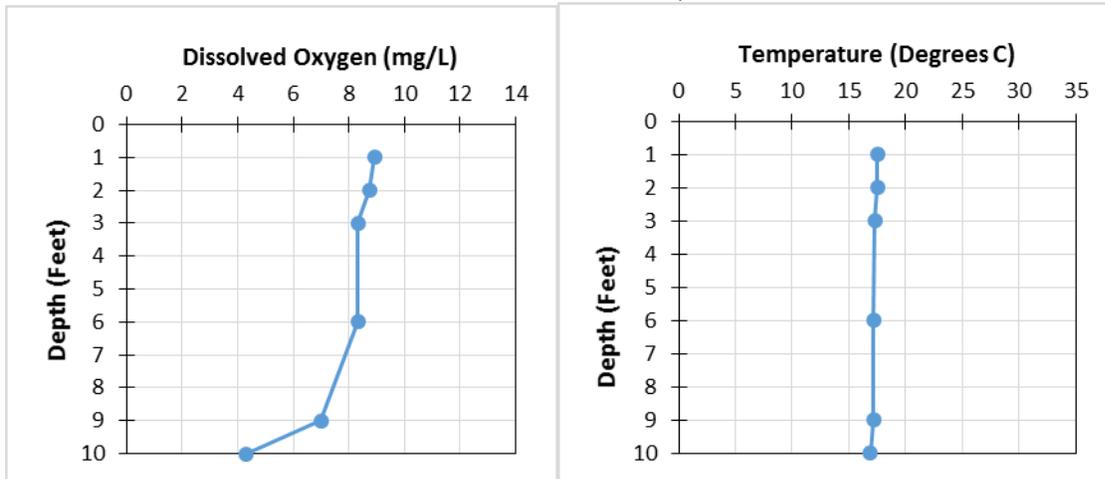
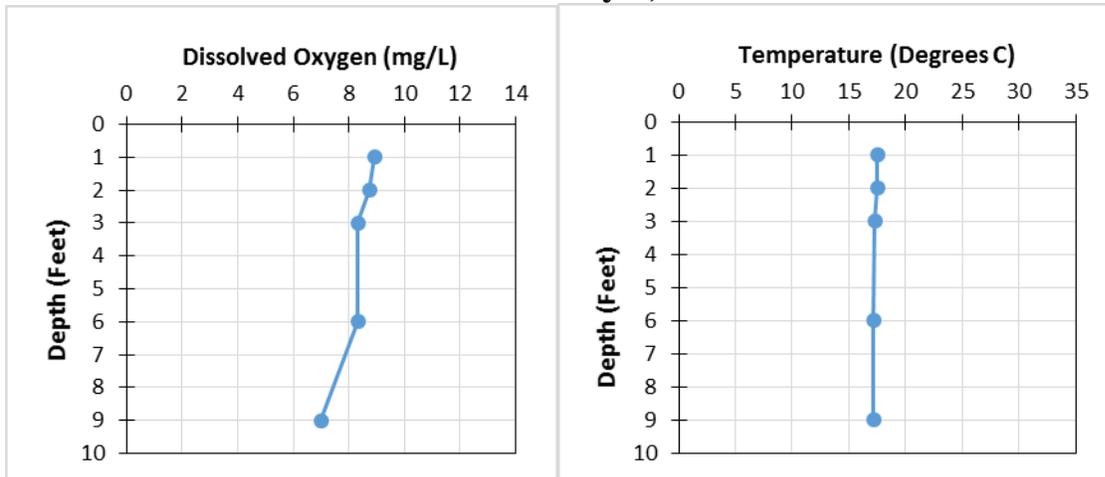
**Figure 2. South Bar Lake Hydrolab Profiles**

- Levels of dissolved oxygen in lake water are adequate, with slight depletion noted near the bottom of South Bar Lake only in the October 2, 2013 sample event. This slight oxygen depletion may be characteristic of biological processes at the lake bottom, including breakdown of organic matter which can consume oxygen, but the depletion is likely not significant enough to result in excessive release of sediment phosphorus or impact fish habitat. Temperature profiles demonstrate a consistent temperature range throughout the water column from surface to bottom. The temperature and dissolved oxygen profiles for the Hydrolab are presented in Figure 2.

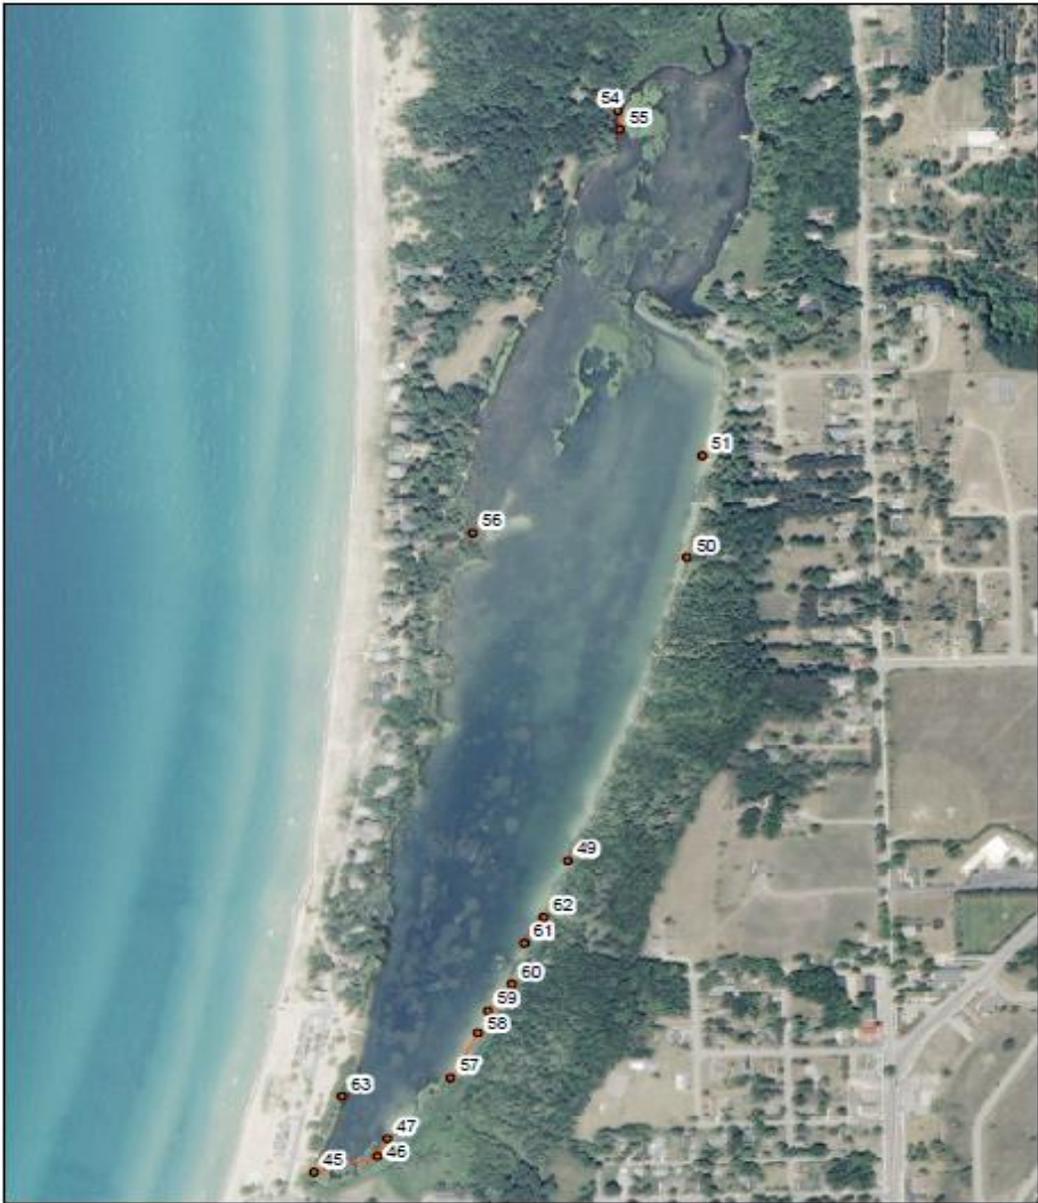
Figure 3: South Bar Lake Cladophora Survey

With respect to chladophora, the survey is conducted by measuring amounts of cladophora, a filamentous algae, in the shallow water shoreline areas for the purpose of determining where phosphorous and /or nitrogen may be entering the lake. The cladophora survey was conducted on 8/7/13 with a total of 11 patches found (Figure 3). Data from the survey was summarized in an Excel spreadsheet and includes information such as GPS coordinates of the patches, patch length and width, length of the strands of cladophora, possible causes, and any relevant notes from the site. Possible causes for the cladophora noted include 'septics' and 'natural causes'. The results indicate that there are no readily apparent causes for the cladophora noted such as lawn fertilization, lakeside dumping, animal waste, and bank erosion. Further, 11 total patches of cladophora are relatively small, but this survey could be repeated in upcoming years to determine any changes in the lake. Note that the 11 patches include some long stretches (#45-47, #57-59, #54-55) which were each considered a single "patch".

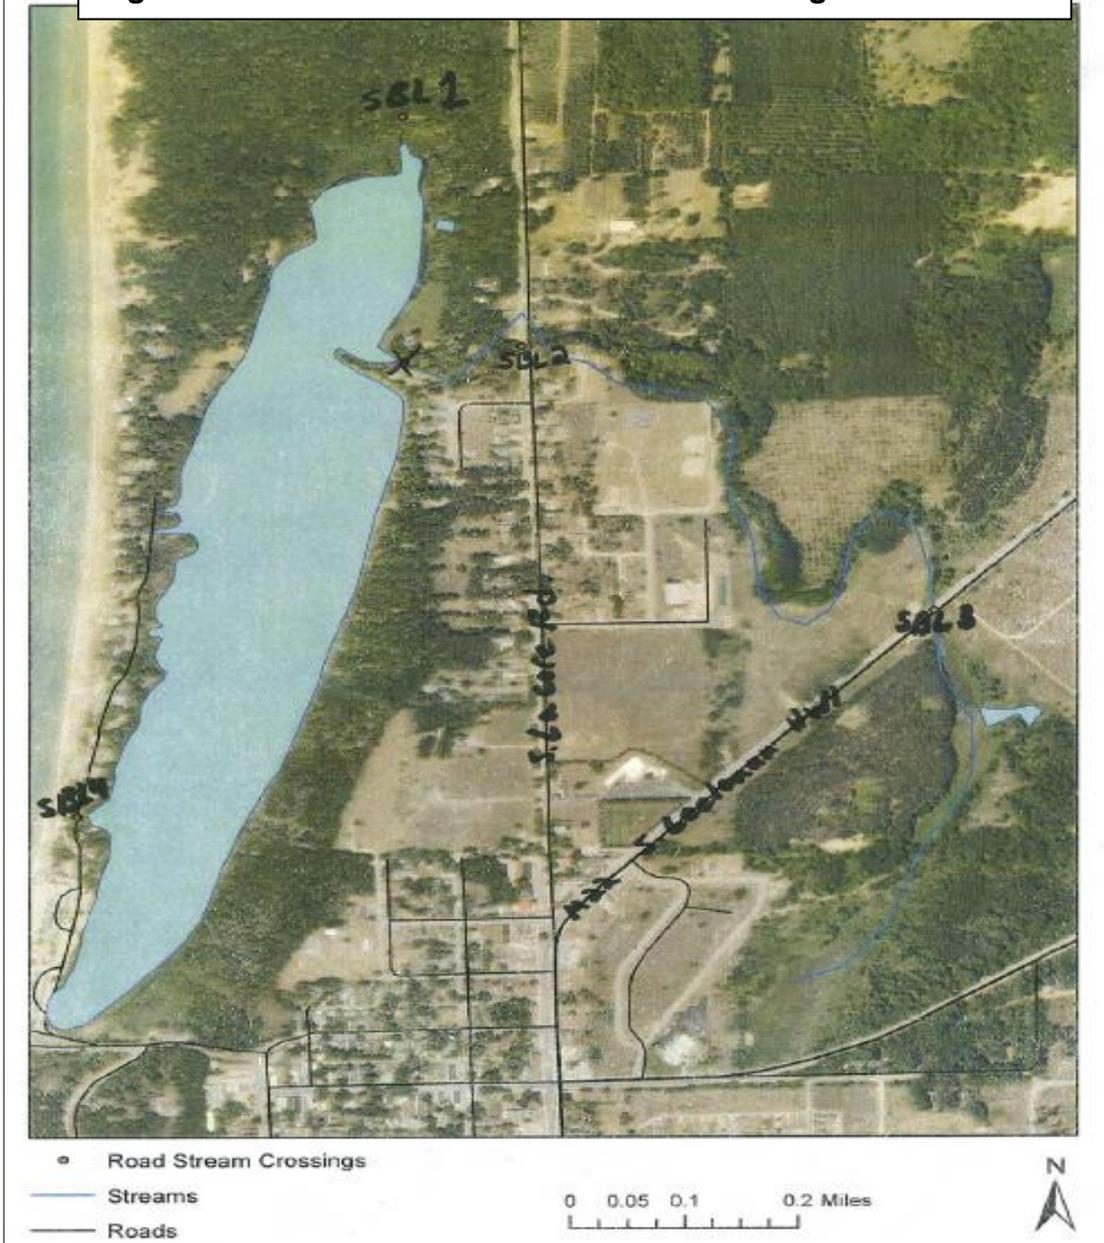
**Figure 4: South Bar Lake Road Stream Crossings**

**Road Stream Crossings.** A total of 4 road stream crossings were analyzed in Spring 2014 using the "Great Lakes Road Stream Crossing Inventory" Instructions and Datasheets developed by Huron Pines and the Wisconsin DNR in April 2011. A map of inventoried sites is below (Figure 4). The inventory documented various types of information for each crossing including: general information (i.e. GPS point, stream/road names), crossing

information (type, structure shape, inlet/outlet type, length/width/height, velocity in crossing, depth of water), stream information (flow level, scour pool or upstream pond present), road information (type, ownership, surface, width, location of low point, approaches, slope of embankment), erosion information, and a site drawing. Site #1 was at a small creek crossing on Lake Michigan Drive at the northern end of South Bar Lake. No major issues were noted at this site. Site #2 was near the Florence Inlet that outlets to South Bar Lake on the Northeast side (see aerial photo, Figure 4). Minor erosion was noted at this site, as well as a small dam and impoundment directly upstream of the crossing location. A large amount of algae was also noted in the downstream portion of the stream, indicating nutrient input from someplace. Site #3 was on the same stream where it crosses M-22, just upstream of Site #2. No major issues were recorded at this site, however, it was noted that the banks down to the stream at this location were quite steep. Site #4 was located at the outlet of South Bar Lake, minor erosion issues resulting from road runoff were noted at this site.

- Investigate possible erosion and sources of nutrients at road/stream crossing #2 near Florence Inlet, as well as some erosion issues due to road runoff at the outlet of South Bar Lake.

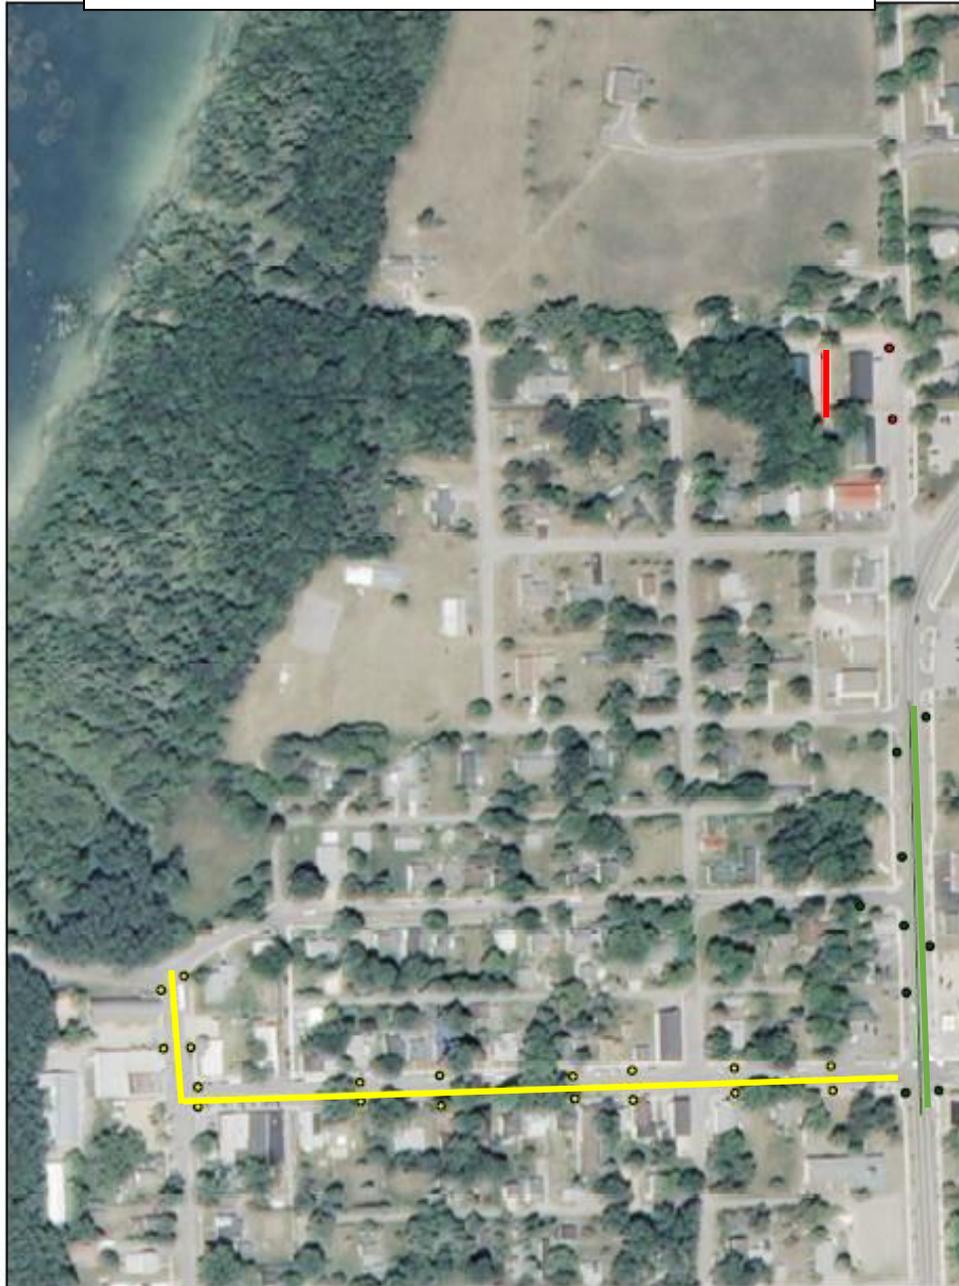
Figure 5: Village of Empire Stormwater Infiltration System

**Stormwater Assessment.** TWC conducted a stormwater assessment for the Village of Empire, similar to those conducted in the Grand Traverse Bay watershed. Since stormwater is one of the main ways pollutants enter a waterbody it is important to effectively manage stormwater inputs coming from all areas, including small communities. In Spring 2014 TWC staff met with the Village's Deputy Clerk and toured the village to conduct the stormwater assessment. Initial conversations with the Deputy Clerk revealed that a series of underground infiltration trenches had been installed throughout the village some years ago to handle their stormwater runoff. The underground infiltration trenches collect stormwater runoff from the roads, rooftops, and parking lots throughout the Village and infiltrate it naturally underground along the Village's two main roads, Front Street and M-22 (Figure 5). Their system is so effective that virtually none of the stormwater runoff in the Village of Empire makes it to surface water. Historically some runoff did make it to a channel originating from a culvert outlet at the corner of Niagra Street and S. Lake Street. However, when the underground infiltration system was installed this outlet was abandoned. Additionally, a raised berm/sidewalk prevents overland surface runoff from making it to this channel. The only flow in the channel at this point is groundwater seepage.

- Because the Village's infiltration trenches handle the stormwater runoff so well, no further recommendations are warranted at this point, other than to stress continued maintenance is key to the proper functioning of their system. Conversations with the Village staff indicated their systems are cleaned out on a yearly basis. The Village of Empire should be commended for being so proactive in addressing stormwater runoff.
