LELAND DAM INSPECTION

Dam Identification No.: 510
Hazard Potential: High
NE Quarter of Section 9, T. 30 N. – R.12 W
Leelanau County, Michigan
Lake Leelanau

Date of Inspection: September 1, 2022
Date of Report: October 2022

Project I.D. Number 131999SG2022

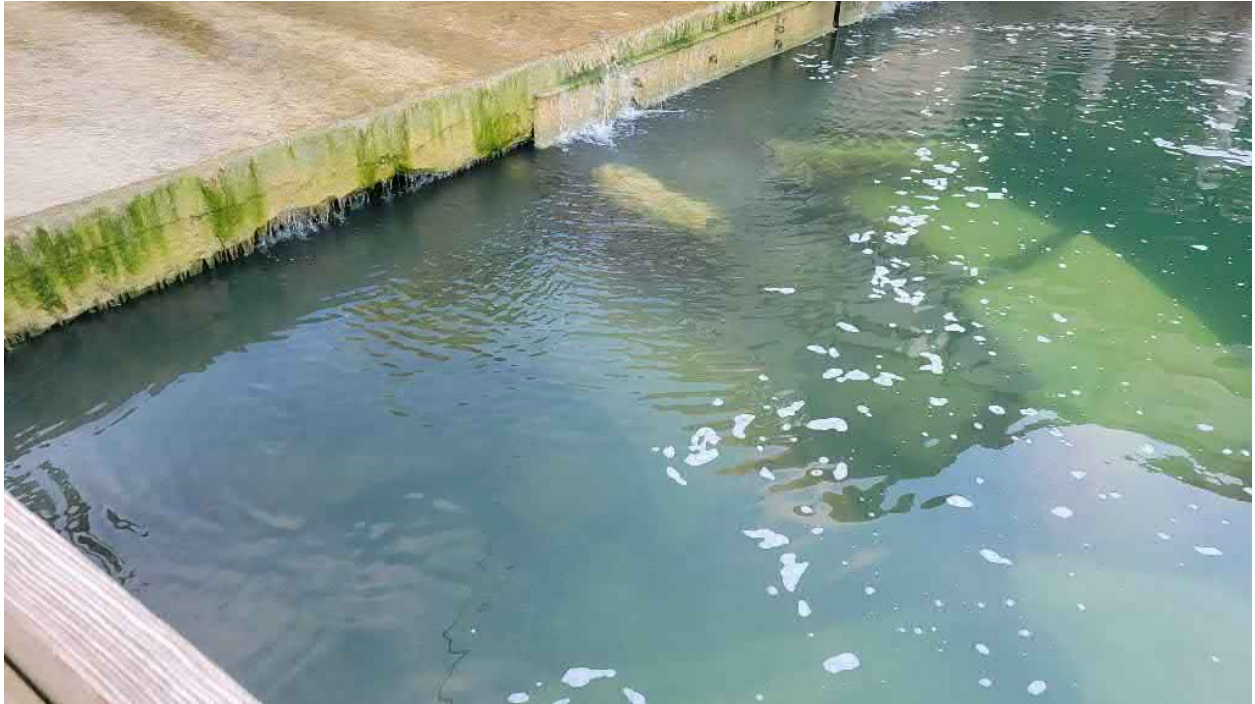
Spillway Observation While Gates are Closed

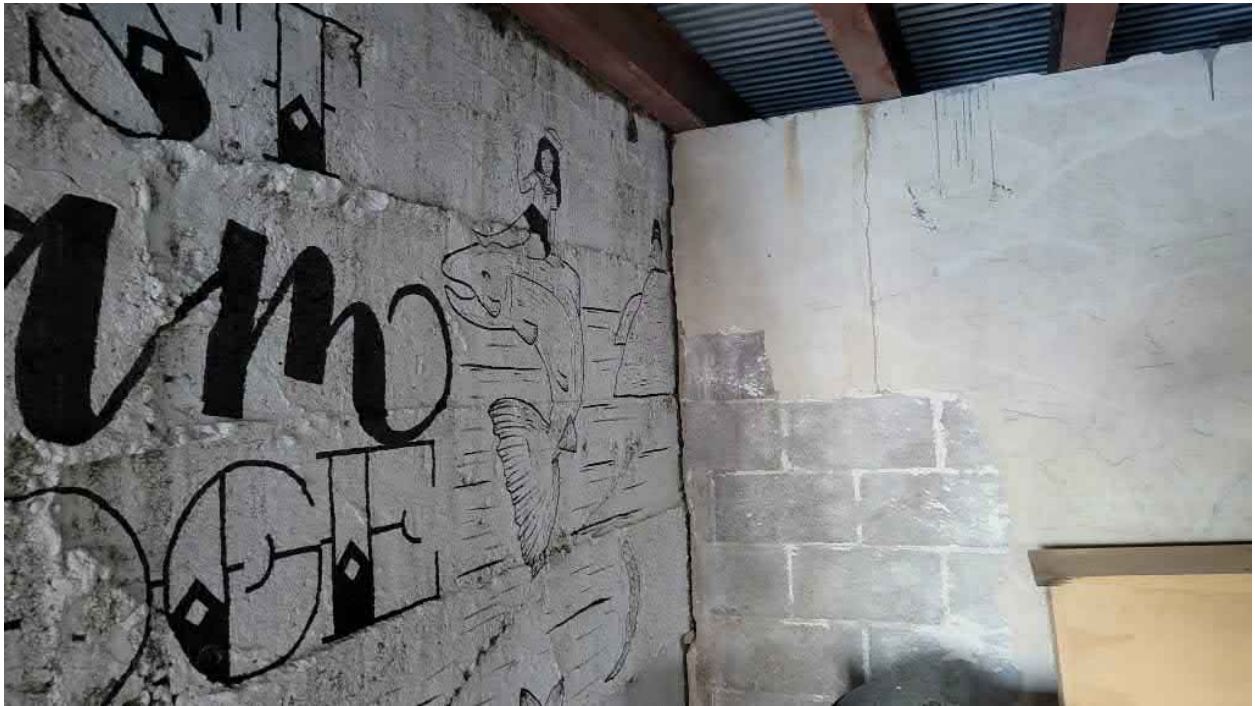
Left Abutment Wall and Wall Adjacent to Dam

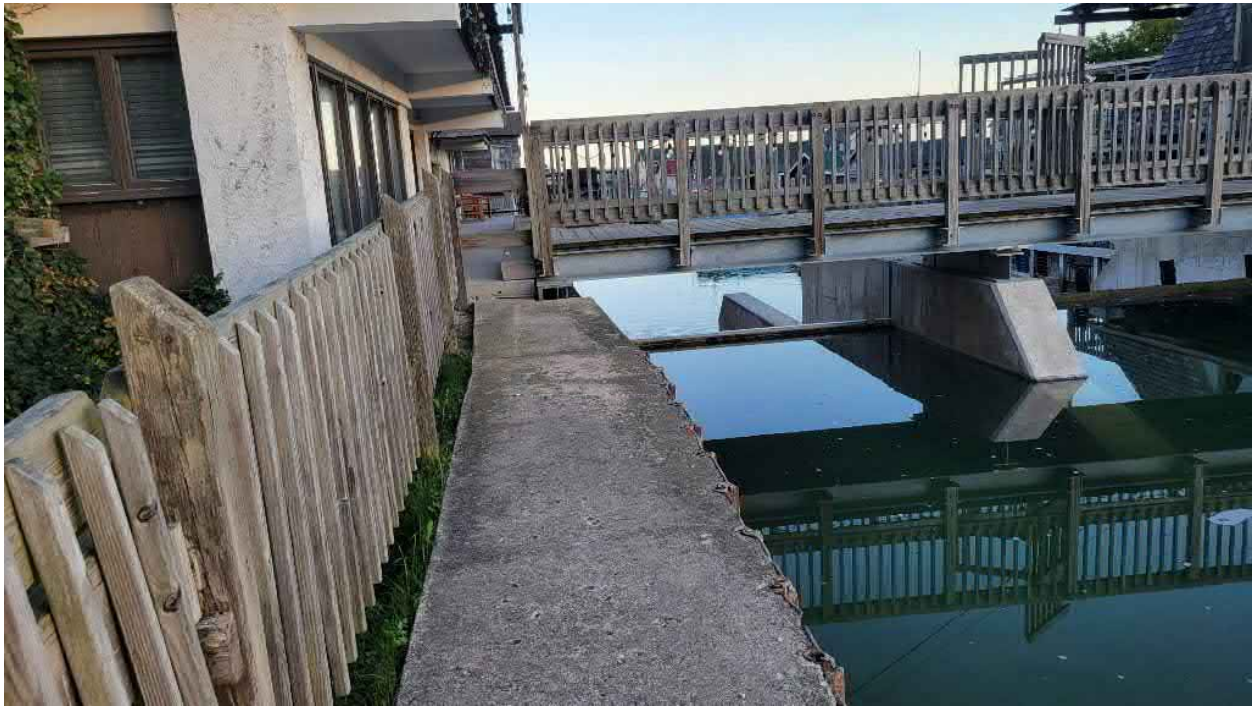
Left Abutment Wall

1. *Observation:* Downstream left abutment wall foundation. Dive inspection observed deep spalling, deteriorated concrete, and exposed rebar below spillway overhang at the downstream end of the left abutment wall. Please refer to the 2019 underwater inspection report in Appendix E for more detail.

Recommendation: Continue to monitor the abutment wall foundation for a change in condition. A repair to this deteriorated concrete such as underpinning, steel sheeting, tremie concrete work, etc. should be designed for permitting and construction purposes. If no work is proposed or completed, another dive inspection should be considered for comparative purposes in five years, or sooner if observed deterioration of the abutment wall foundation worsens.

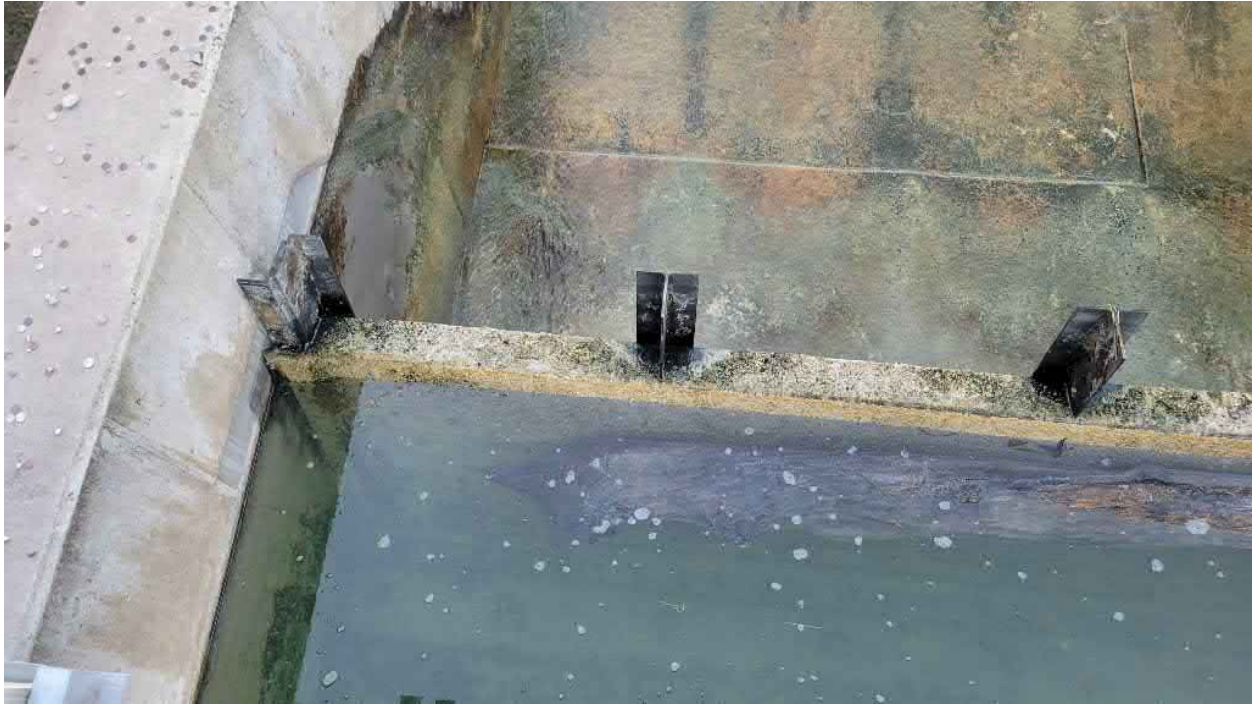
Closed Hydraulic Gate (Left Side)

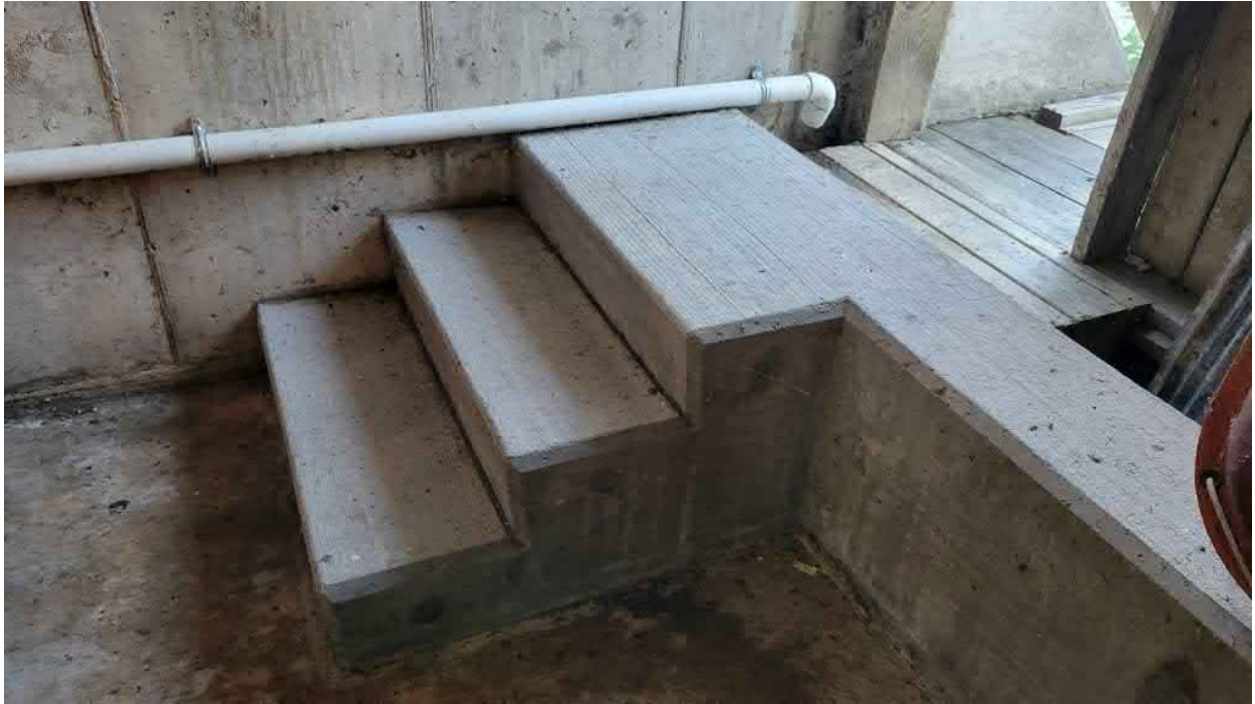
Control Room - Concrete Curb Flood Protection

Recommendation: Install a temporary or permanent means to prevent this backflow, such as removable watertight stoplogs, low floodproofing gates, concrete curb etc. A means to pump out this area will also need to be in place to dewater when the river is too high to allow for draining by gravity.

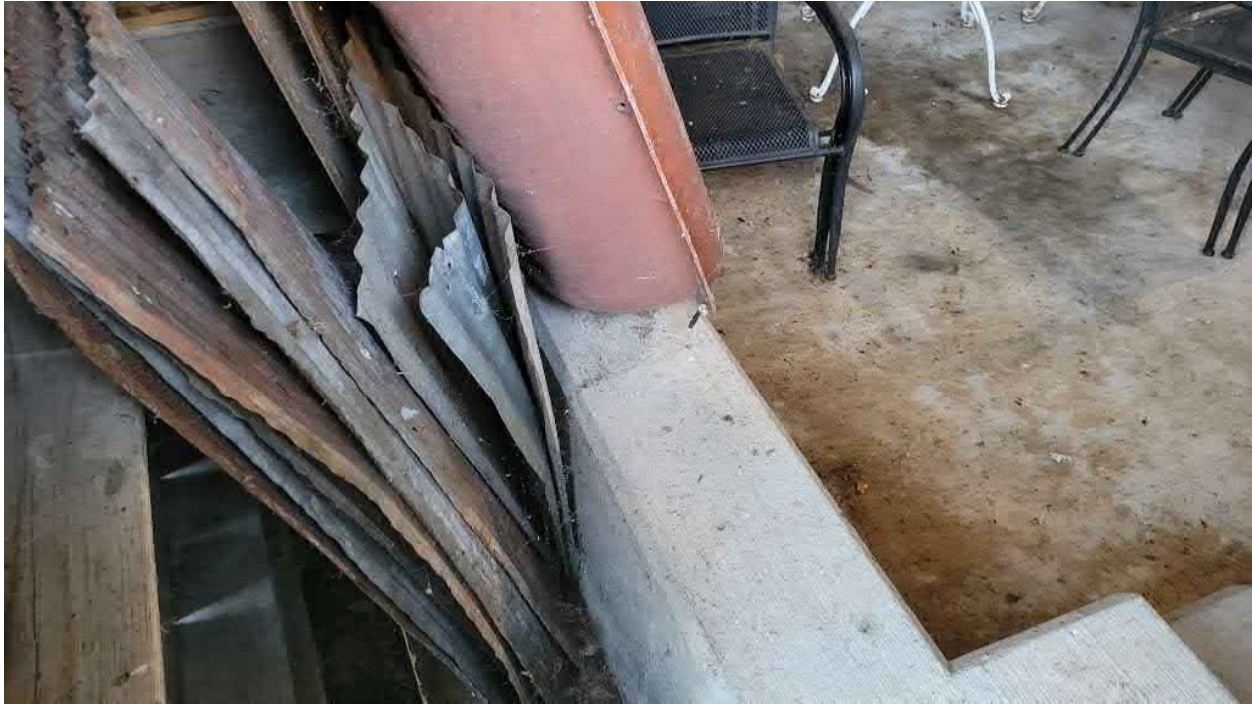
Control Room - Concrete Curb Flood Protection

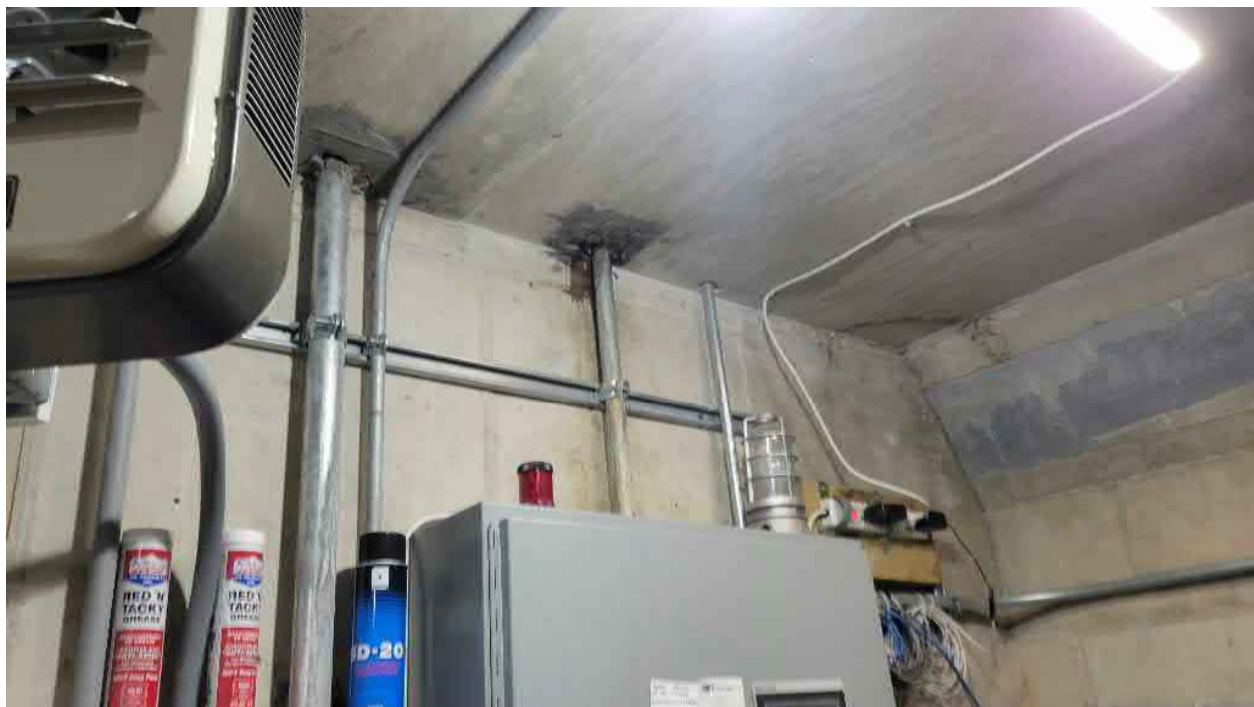
Control Room - Electrical Panel

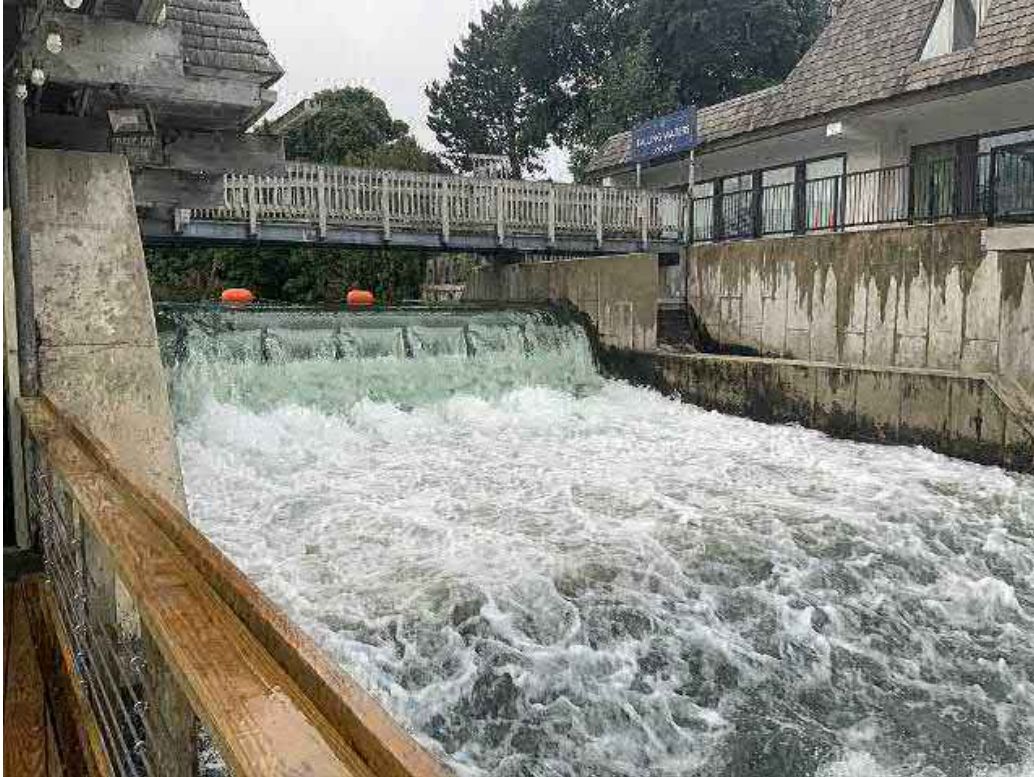
Looking south at downstream face of principal spillway (actuated weirs).

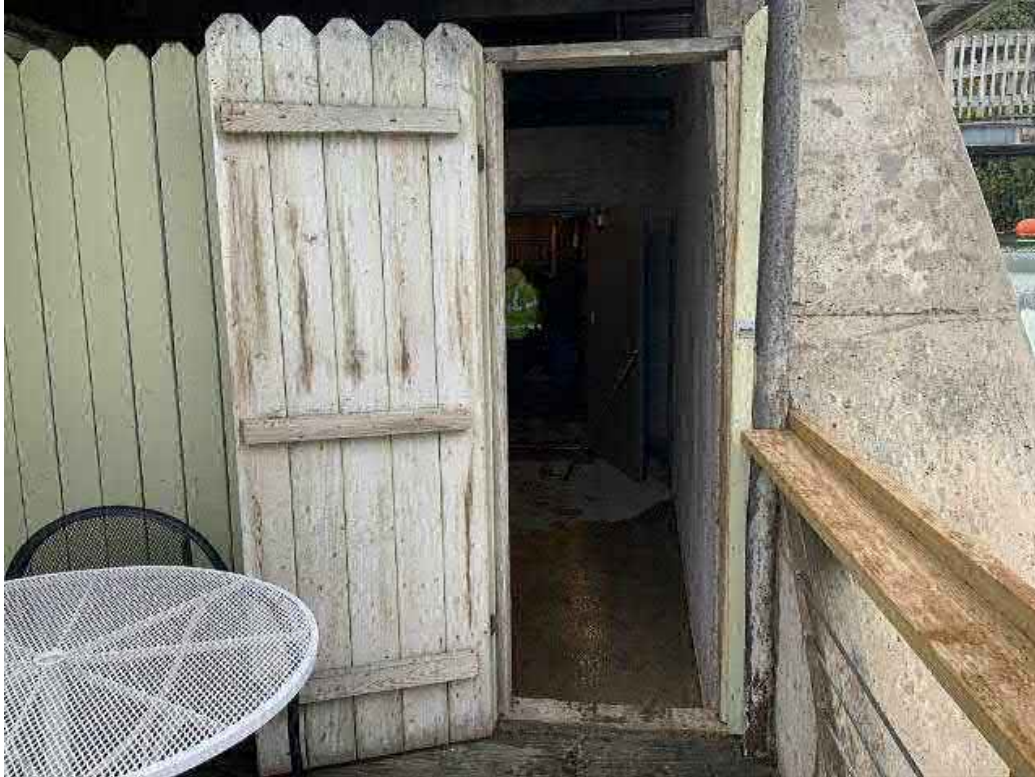
Wooden gate door downstream from just downstream of main door into hydraulics / control room (former Bay #4).

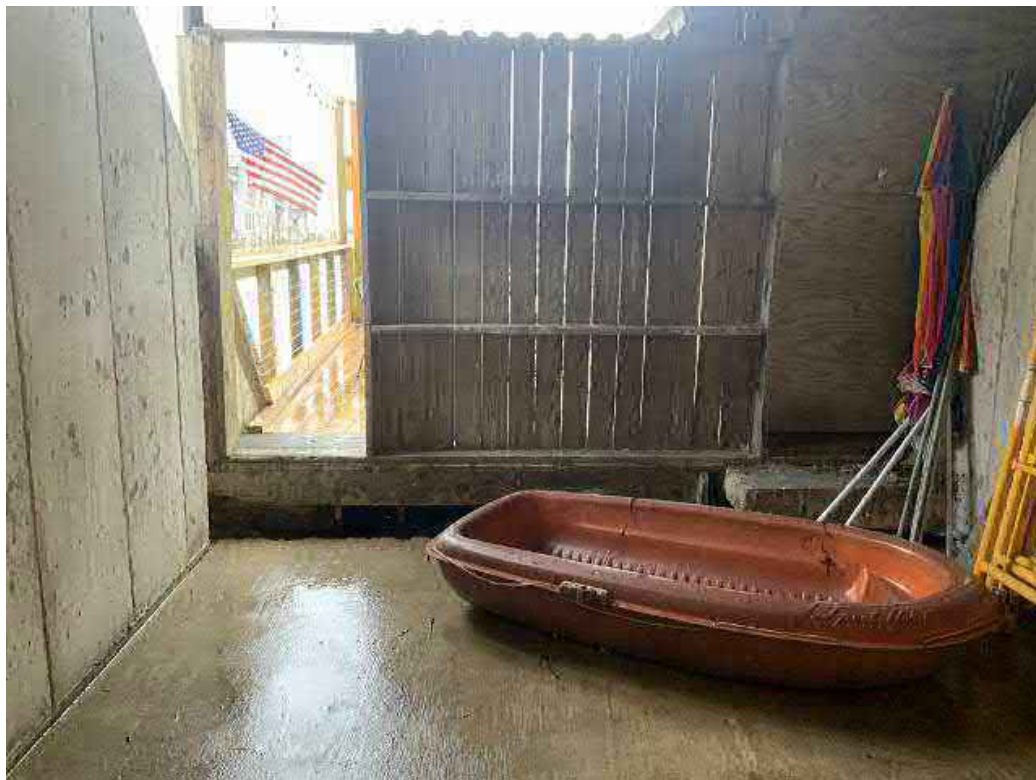
Looking downstream from just downstream of main door into hydraulics / control room.

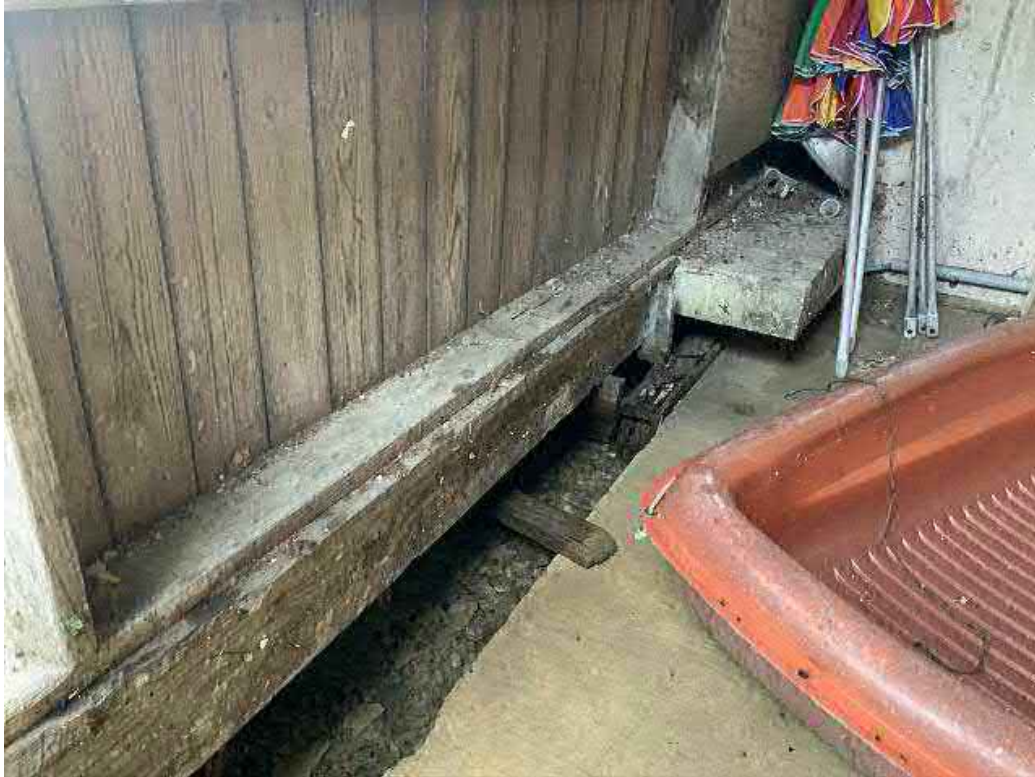
Looking northeast along former downstream end of Bay #4 spillway, downstream of hydraulics / control room.

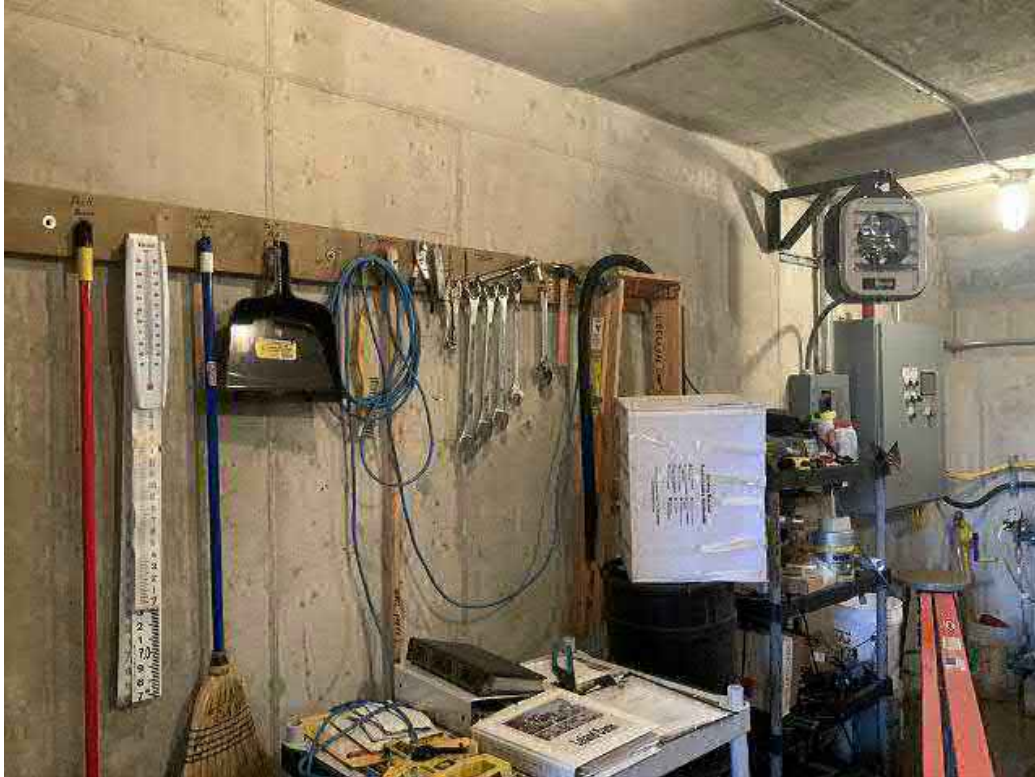
Looking east at corner of hydraulics / control room.

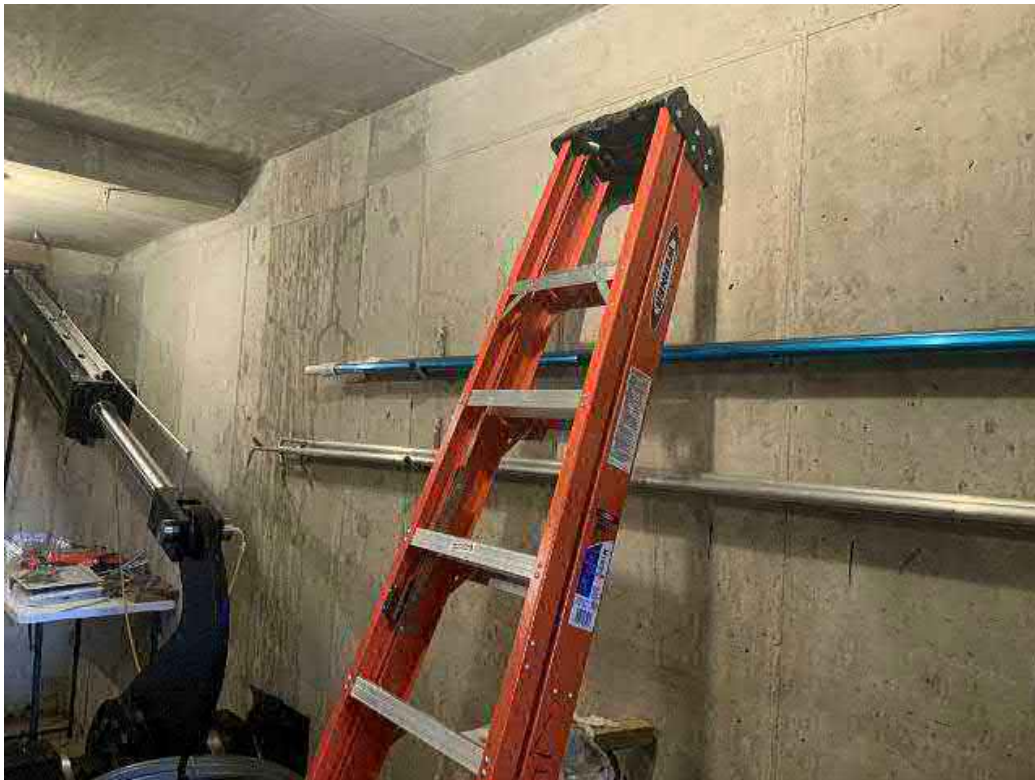
Looking south at south corner within hydraulics / control room.

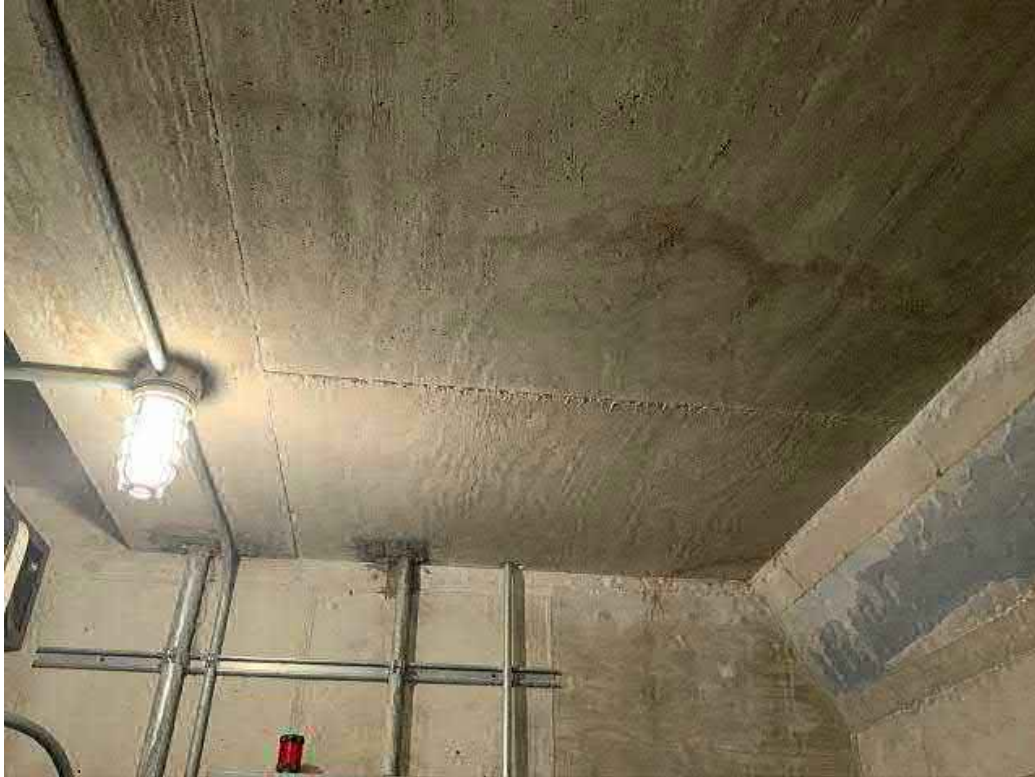
Looking northeast at ceiling of hydraulics / control room.

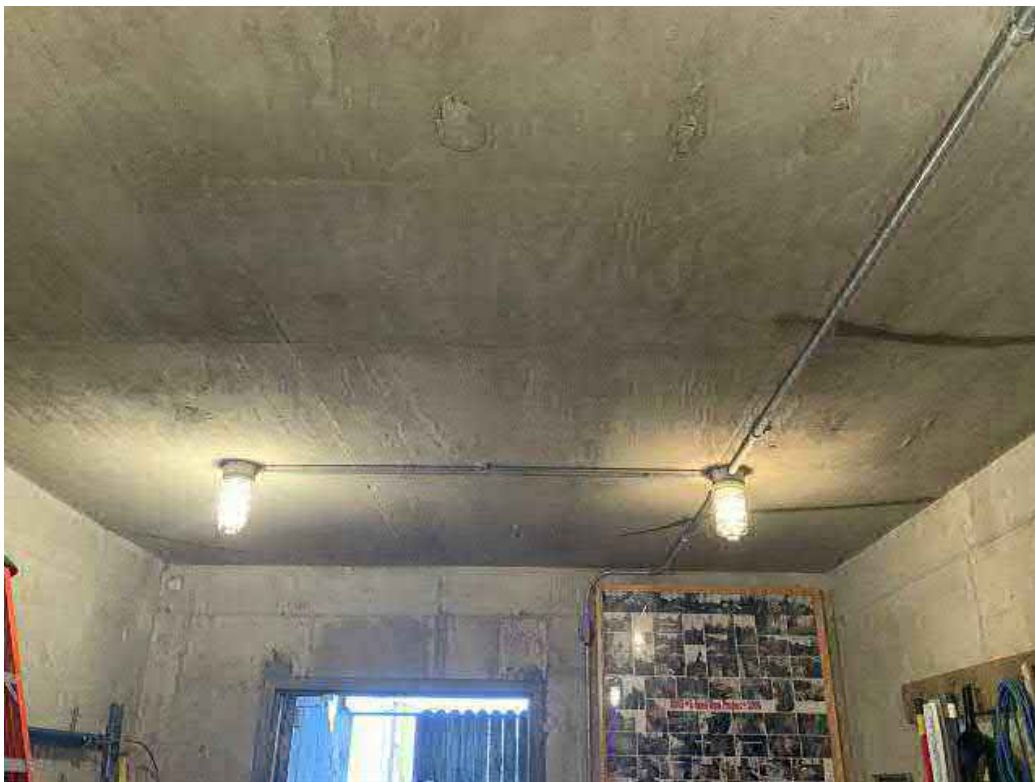
Looking northwest at ceiling within hydraulic / control room.

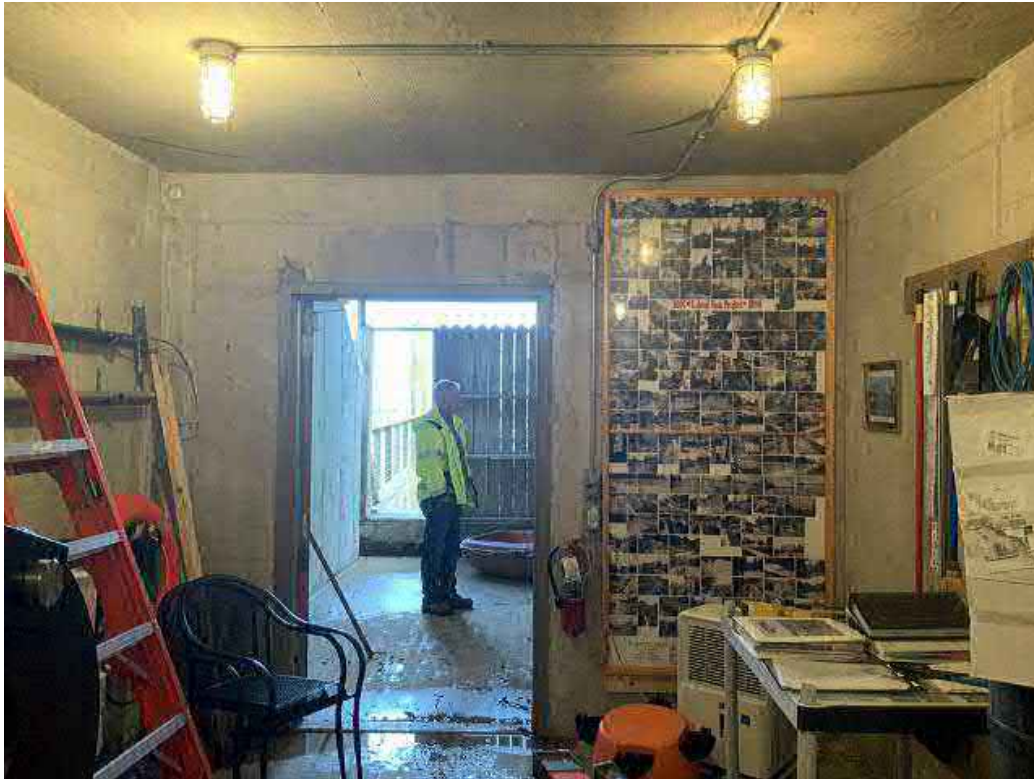
Looking northwest at entrance door and northwest wall of hydraulic / control room.

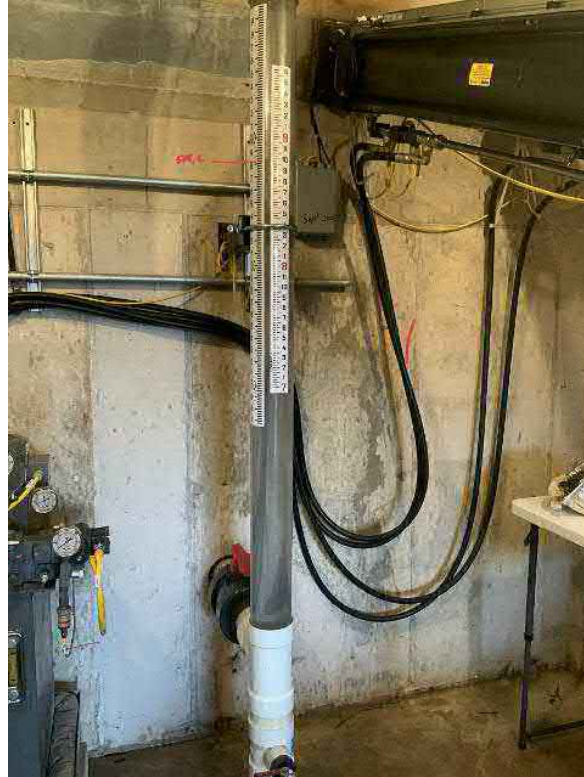
Water Level Gauge - reading 598.2' on date on inspection.

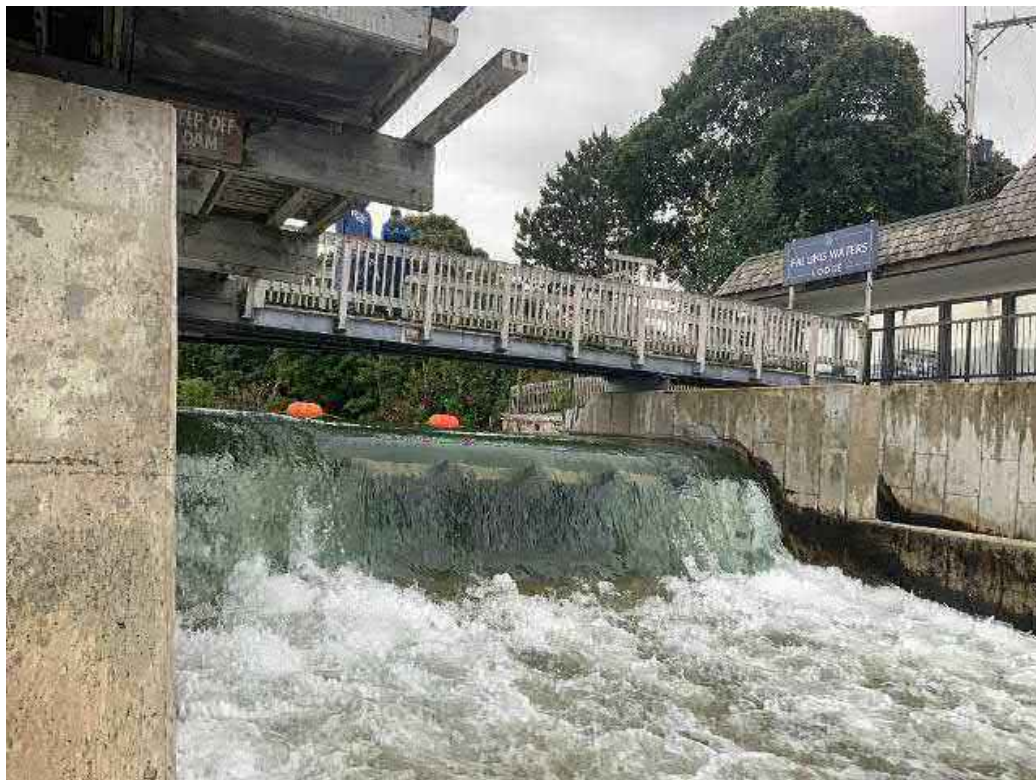
Looking southeast principal spillway (actuated weir gate).

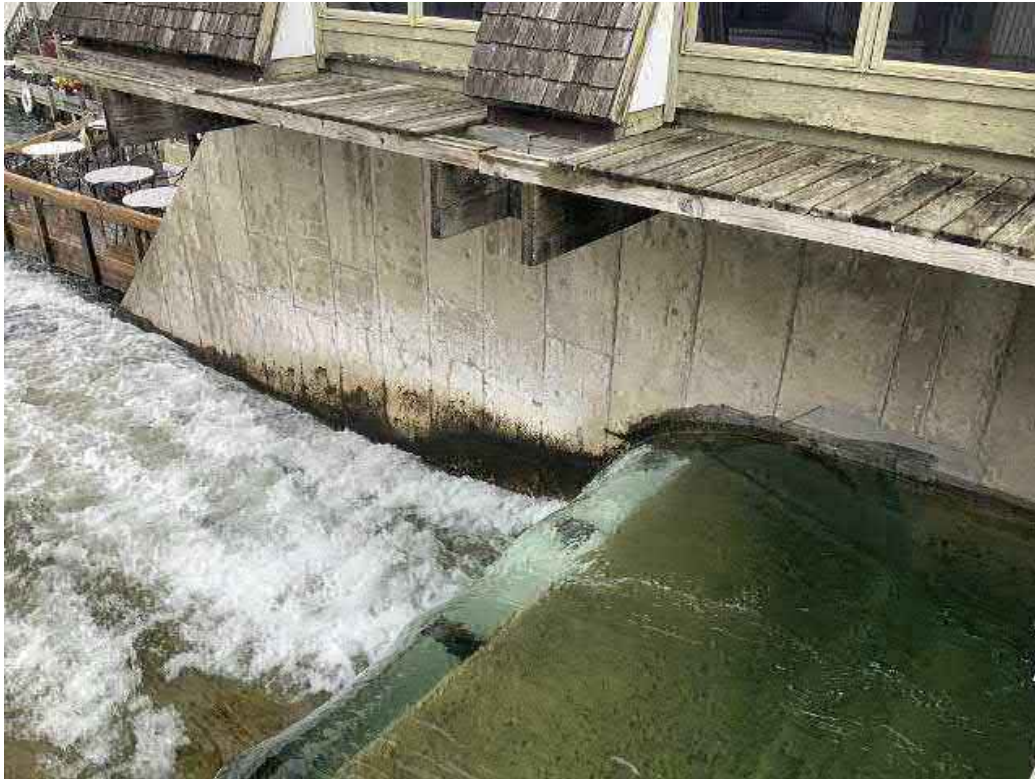
Looking north from walkway at top of actuated weir and right principal spillway abutment wall.

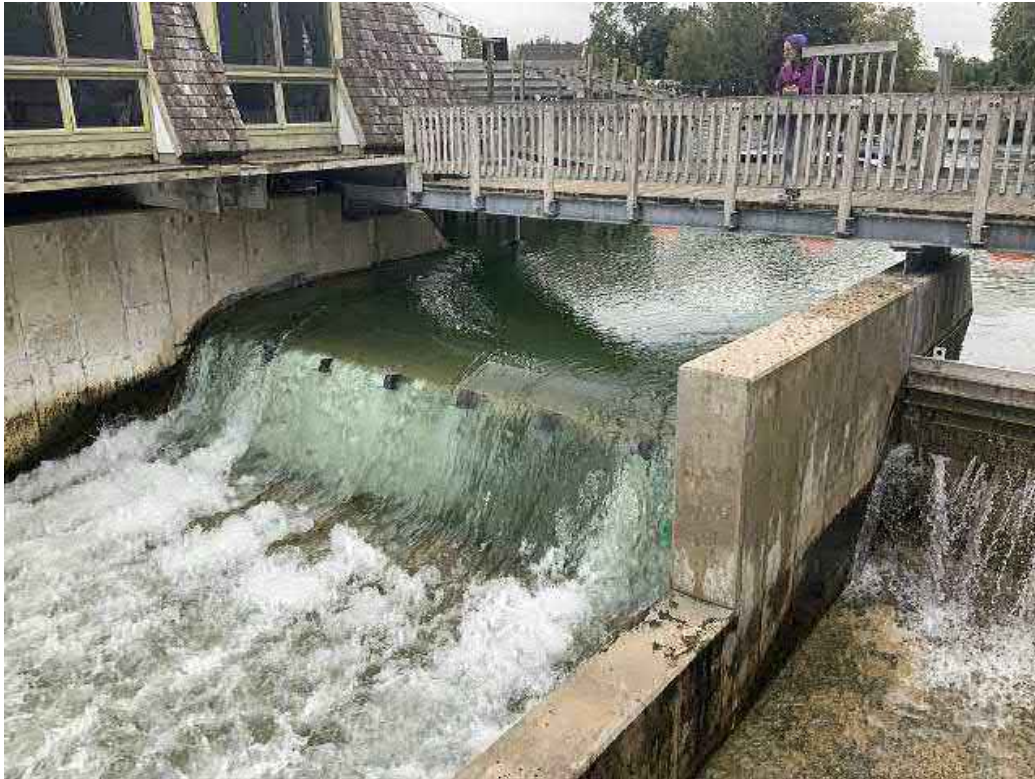
Looking east at principal spillway (actuated weir gate).

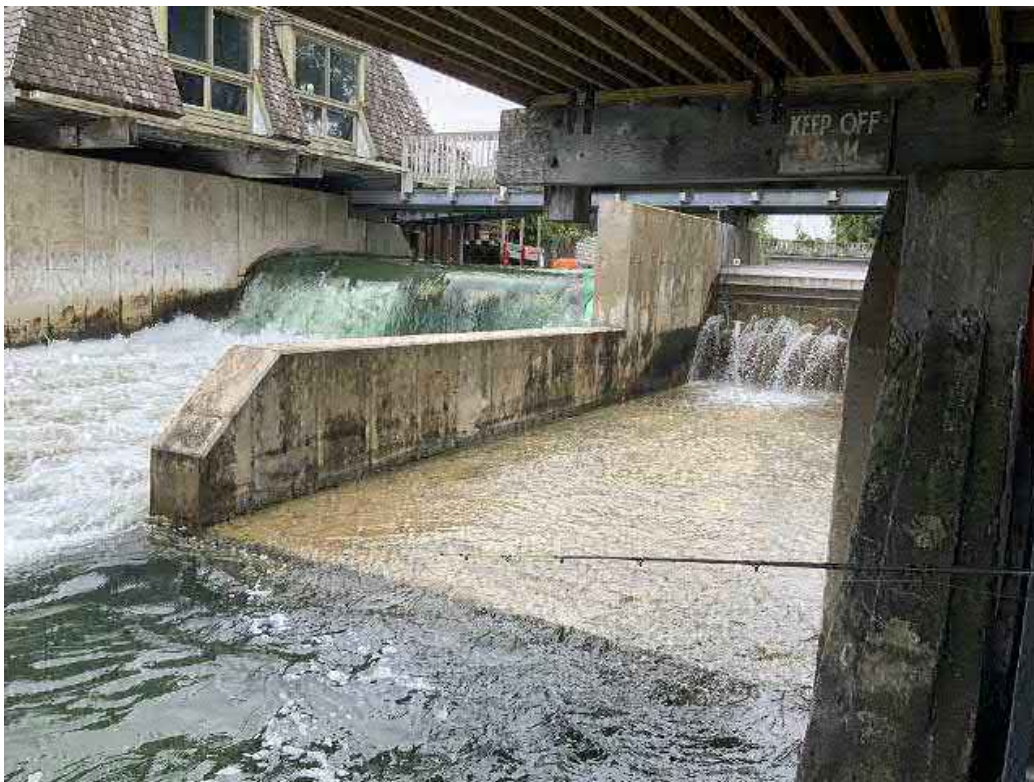
Looking east across downstream end of Bay #1 spillway.

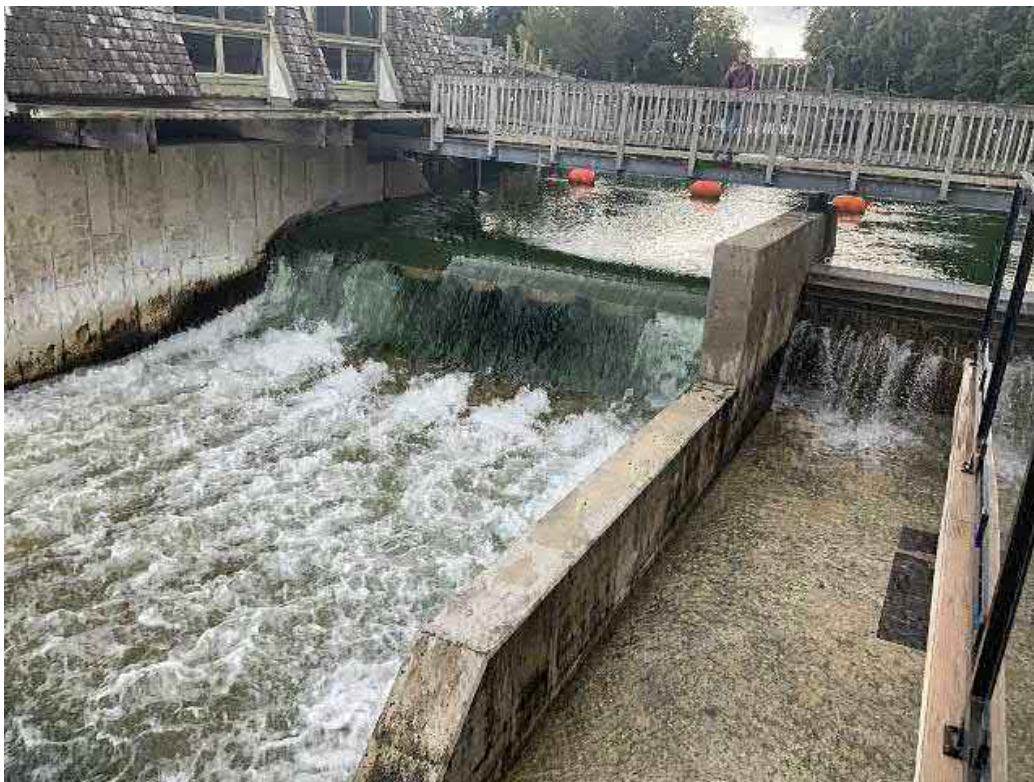
Looking southeast at Principal (former Bay #2 and #3) and fixed crest / stoplog (Bay #1) spillway.

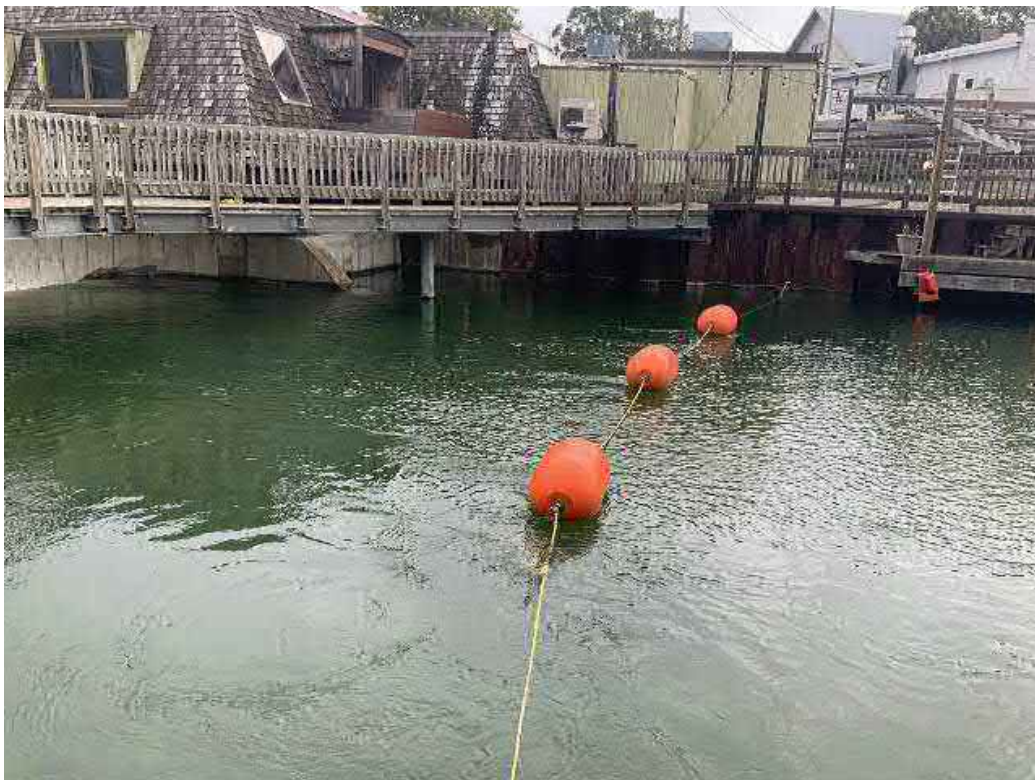
Looking northeast across upstream side of dam (warning buoys).

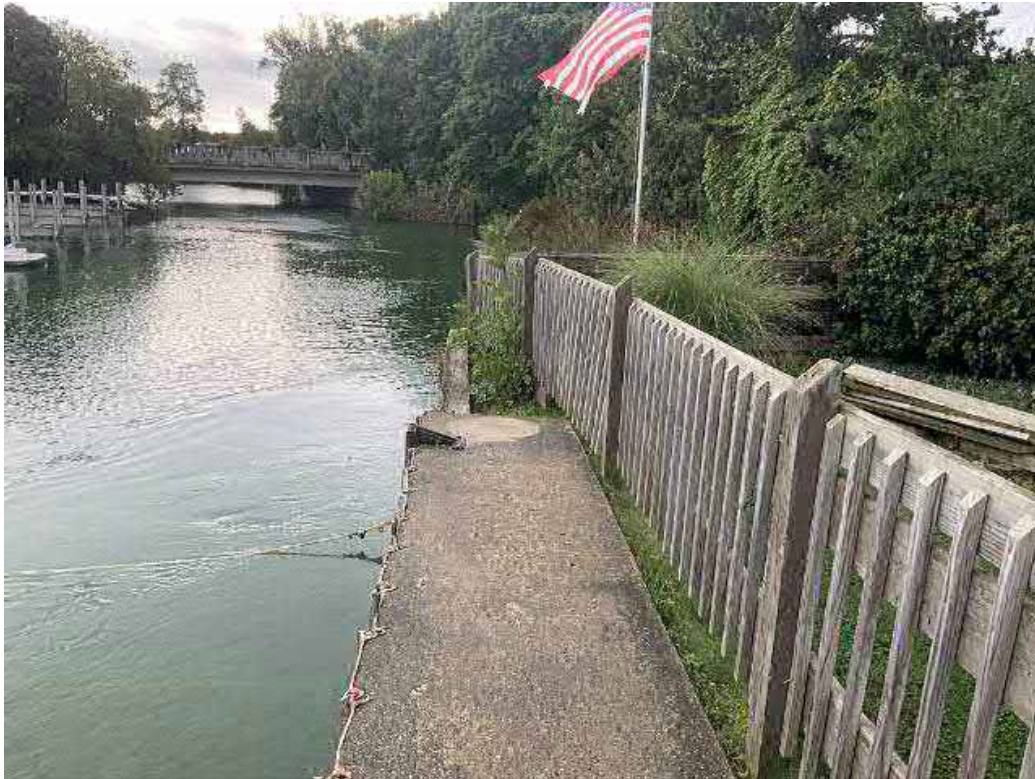
Looking southeast at upper end of left approach abutment wall and wooden seawall.

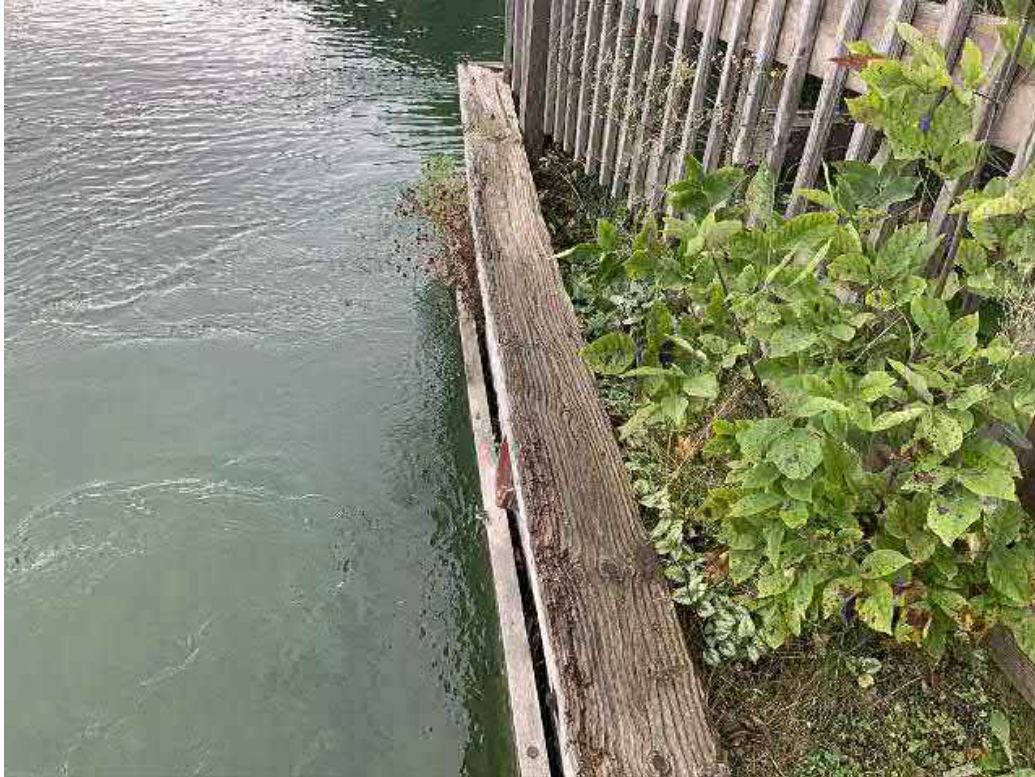
Looking northwest at wooden seawall from northwest (upstream) end of left abutment wall.

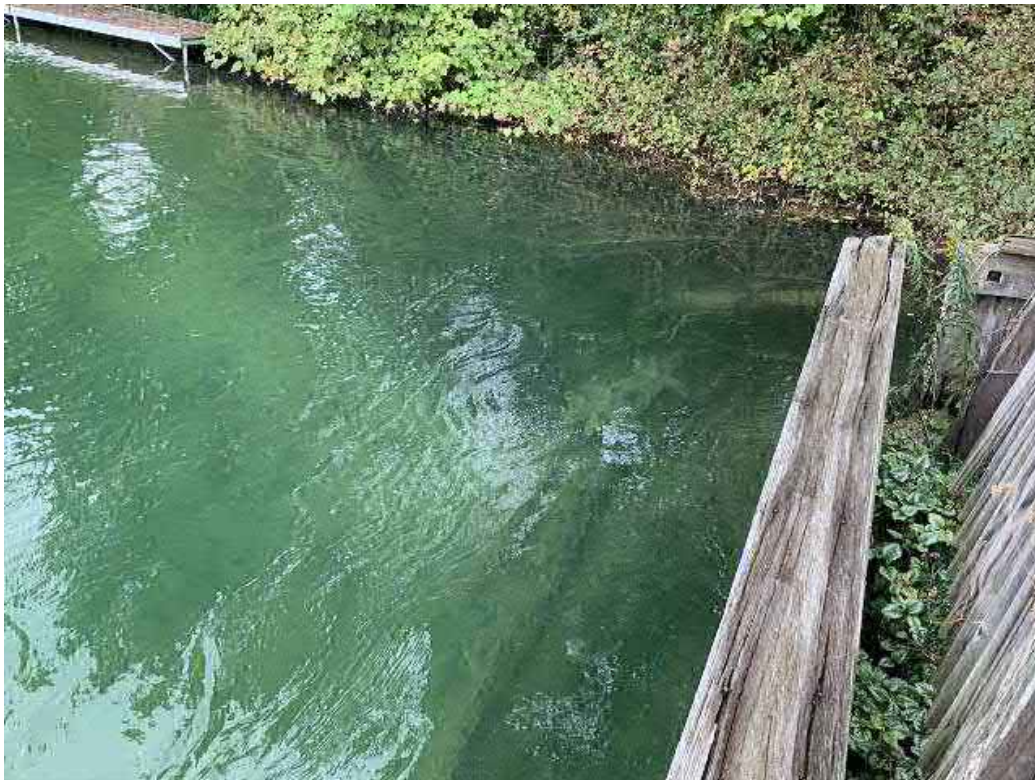
Looking northeast along turned back portion of wooden seawall (left side of channel, upstream of left abutment wall)

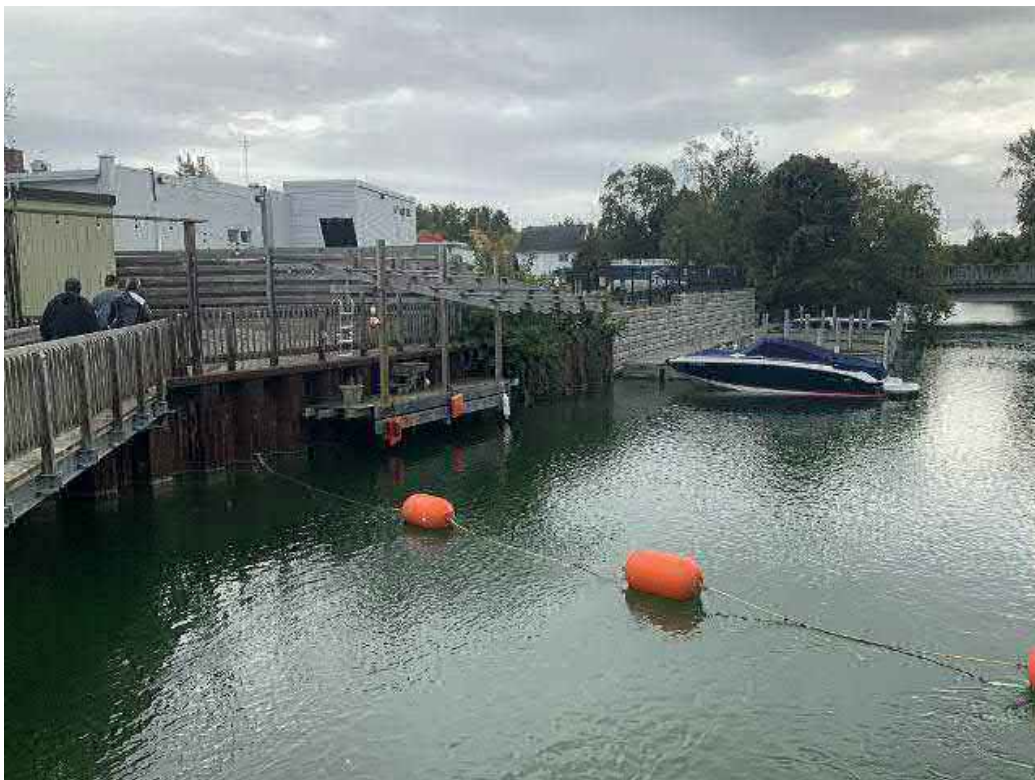
Looking east at upstream channel, warning buoys and walkway.

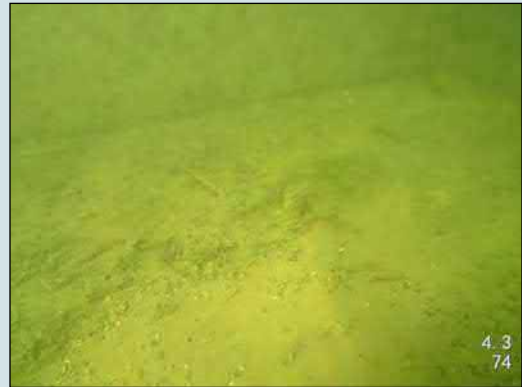
Left abutment and spillway (upstream end)

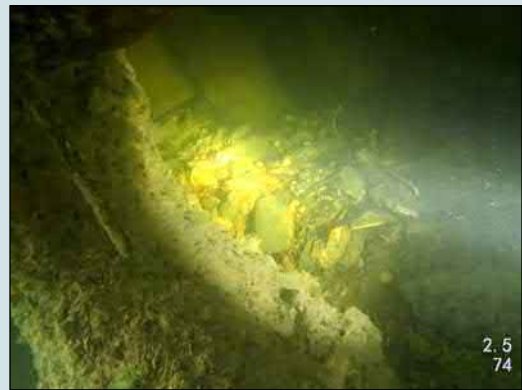
The left abutments consist of a solid abutment wall founded on a concrete slab footing. The portion above the spillways has been rehabilitated and in good condition. The portion under the downstream spillway, downstream of the cutoff wall, has deep spall with exposed rebar.

Left abutment (downstream end)
