LELAND DAM INSPECTION

Dam Identification No.: 510
Hazard Potential: High
NE Quarter of Section 9, T. 30 N. – R.12 W
Leelanau County, Michigan
Lake Leelanau

Date of Inspection: September 1, 2022
Date of Report: October 2022

Project I.D. Number 131999SG2022

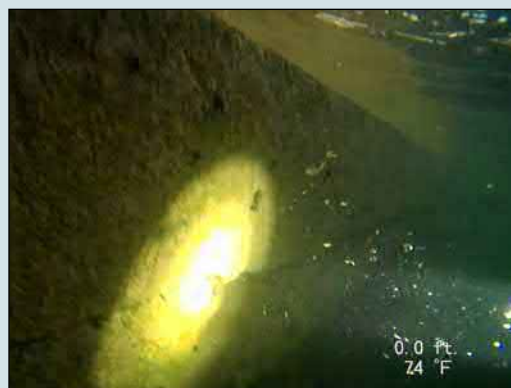
The downstream spillway is a concrete slab that overhangs a cutoff wall by up to 4'. The slab is up to 4' above the channel bottom at the cutoff wall. The end of the spillway overhang slab has scattered spalls on both the top and bottom. There is a steel stringer edging on the end of the overhang which is missing in bay 3 and has heavy rust and pitting in the remaining locations. The spillway slab is in good condition other than the end 3" where spalls were noted.

There was a small area (approximately 3' long) in bay 3 that undermining of the edge of the cutoff wall was observed. The vertical height at the edge of the cutoff wall was approximately 1" and penetration was 2" or less. The cutoff wall has 1" to 3" deep scale throughout.

Downstream edge of spillway

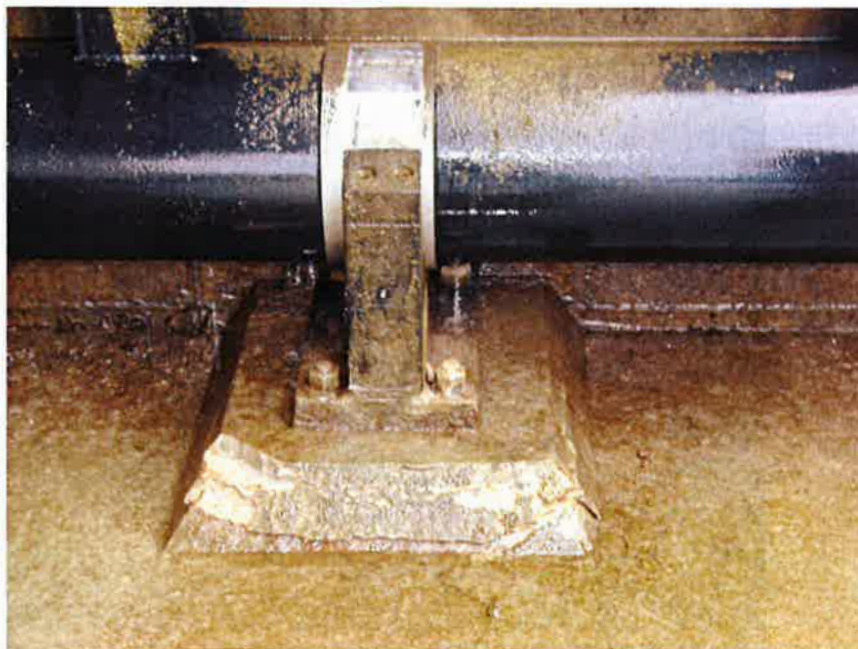
- The existing spillway structure is in excellent condition and can safely pass the 200-year flood event as required by the MDEQ.
- The automated, hydraulically controlled crest gate functions as designed.
- No seepage was noted downstream of the spillway structure.
- A floating cable system has been installed as a safety measure to alert boaters of the spillway structure and to restrict encroachment to the spillway.
- Minor spalling of the crest gate bearing grout pads was noted. However, the grout pads are not structurally significant.

Photo 5. View of spalled grout gate bearing pad.

1. Continue routine maintenance of the hydraulic crest gate and bearings.
2. Schedule future repair of gate bearing grout pads, as necessary.
