**LEELANAU COUNTY PARK...VERONICA VALLEY**  
**FISH POND WATER BANK RESTORATION**

Project Description and Goal: To remove excess fill material and reconstruct about 160 linear feet of eastern peninsula to provide for safe walking and standing.

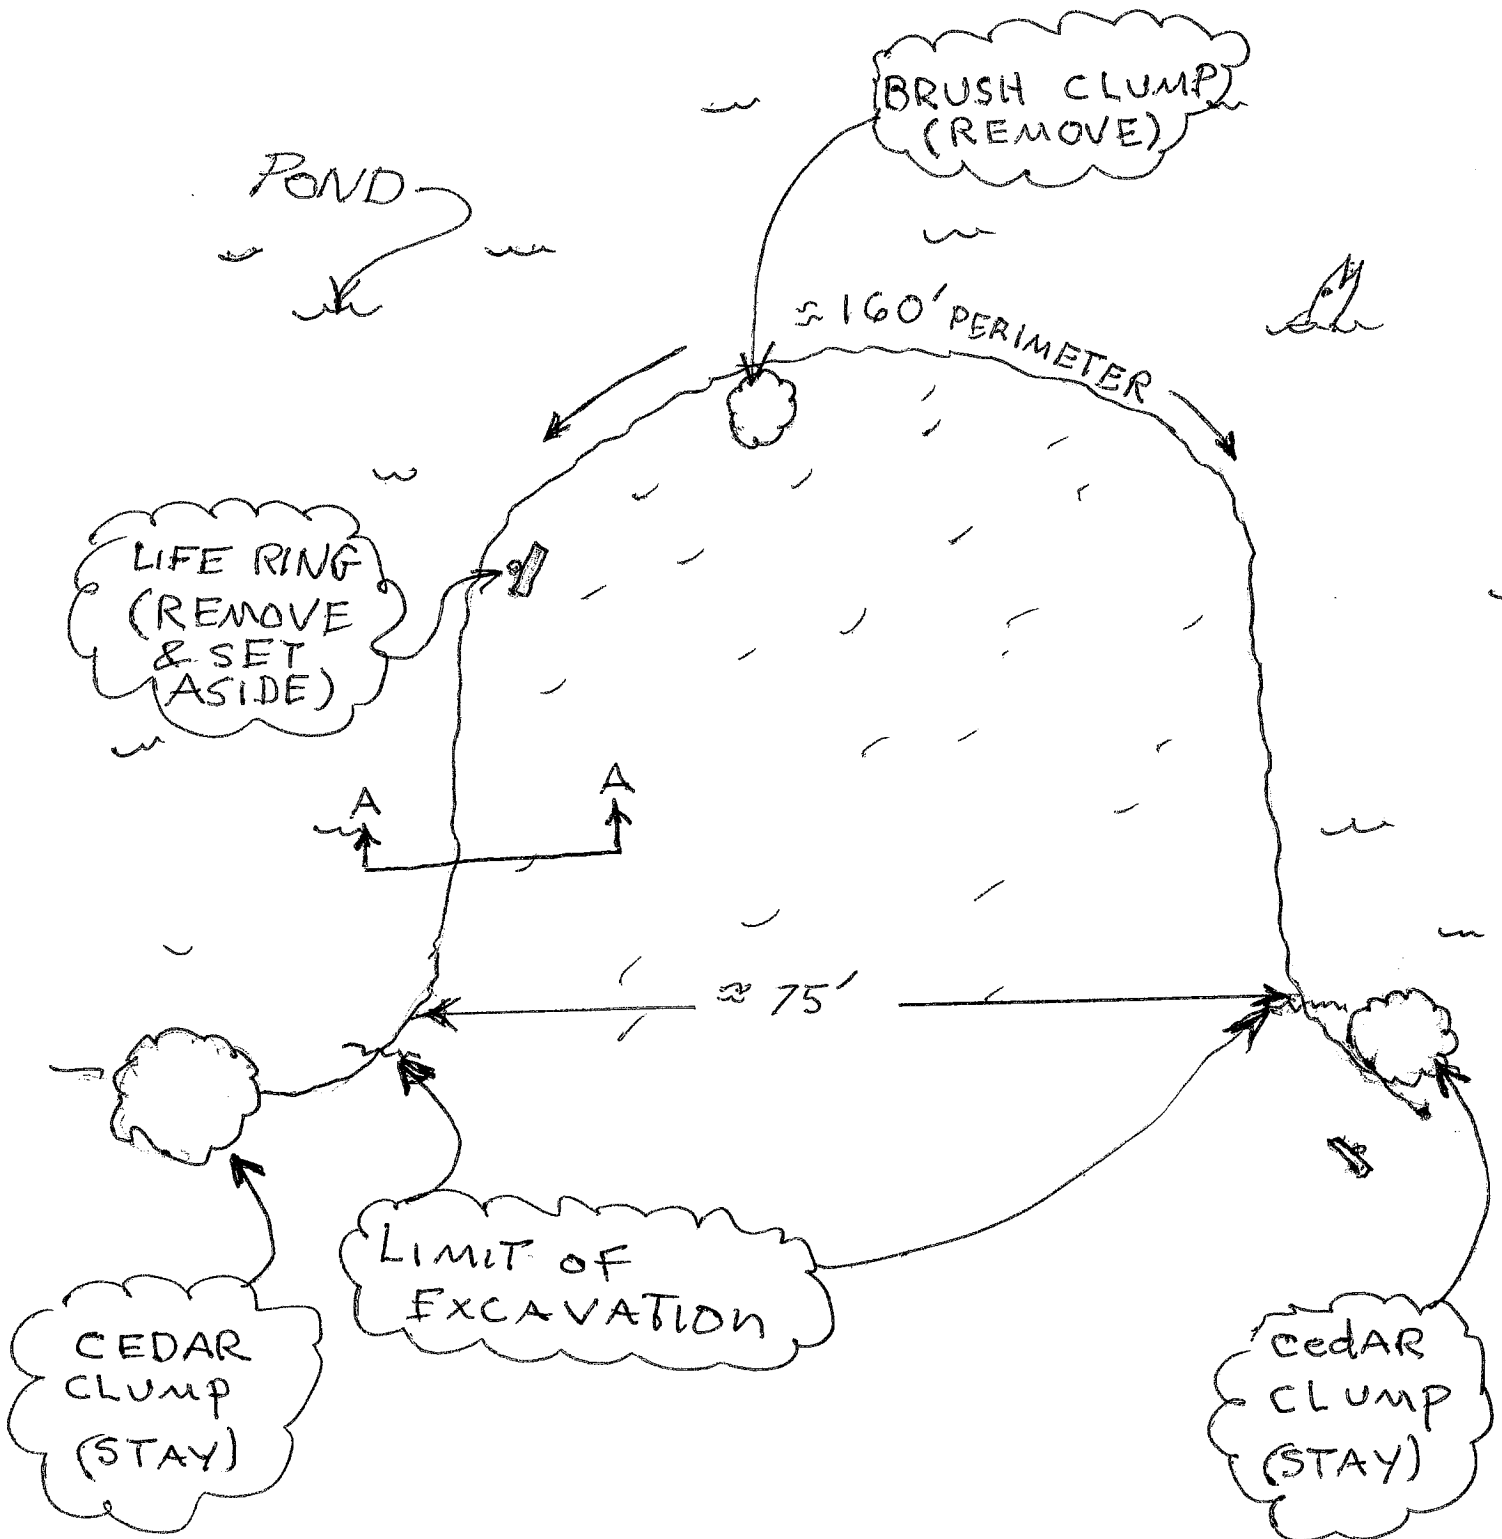
# PENINSULA TO Be Modified

1. Remove dirt, sod, soils, etc. both above and below waterline.
2. Remove cedar post uprights and cedar post backing walls
3. Reshape slope on 1-1 gradient on land side of posts (portion that will be future underwater.
4. Create a four (4) foot wide flat walking/standing surface behind future water line, the surface which should be one (1) foot above the water line.
5. Install about three (3) inches of drain stone on the walking/standing surface.
6. Reshape soils behind the walking/standing surface on a 2-1 slope.
7. Grade, smooth and then seed disturbed soils and/or equipment ruts.
8. DEQ permits will be obtained by Leelanau County.

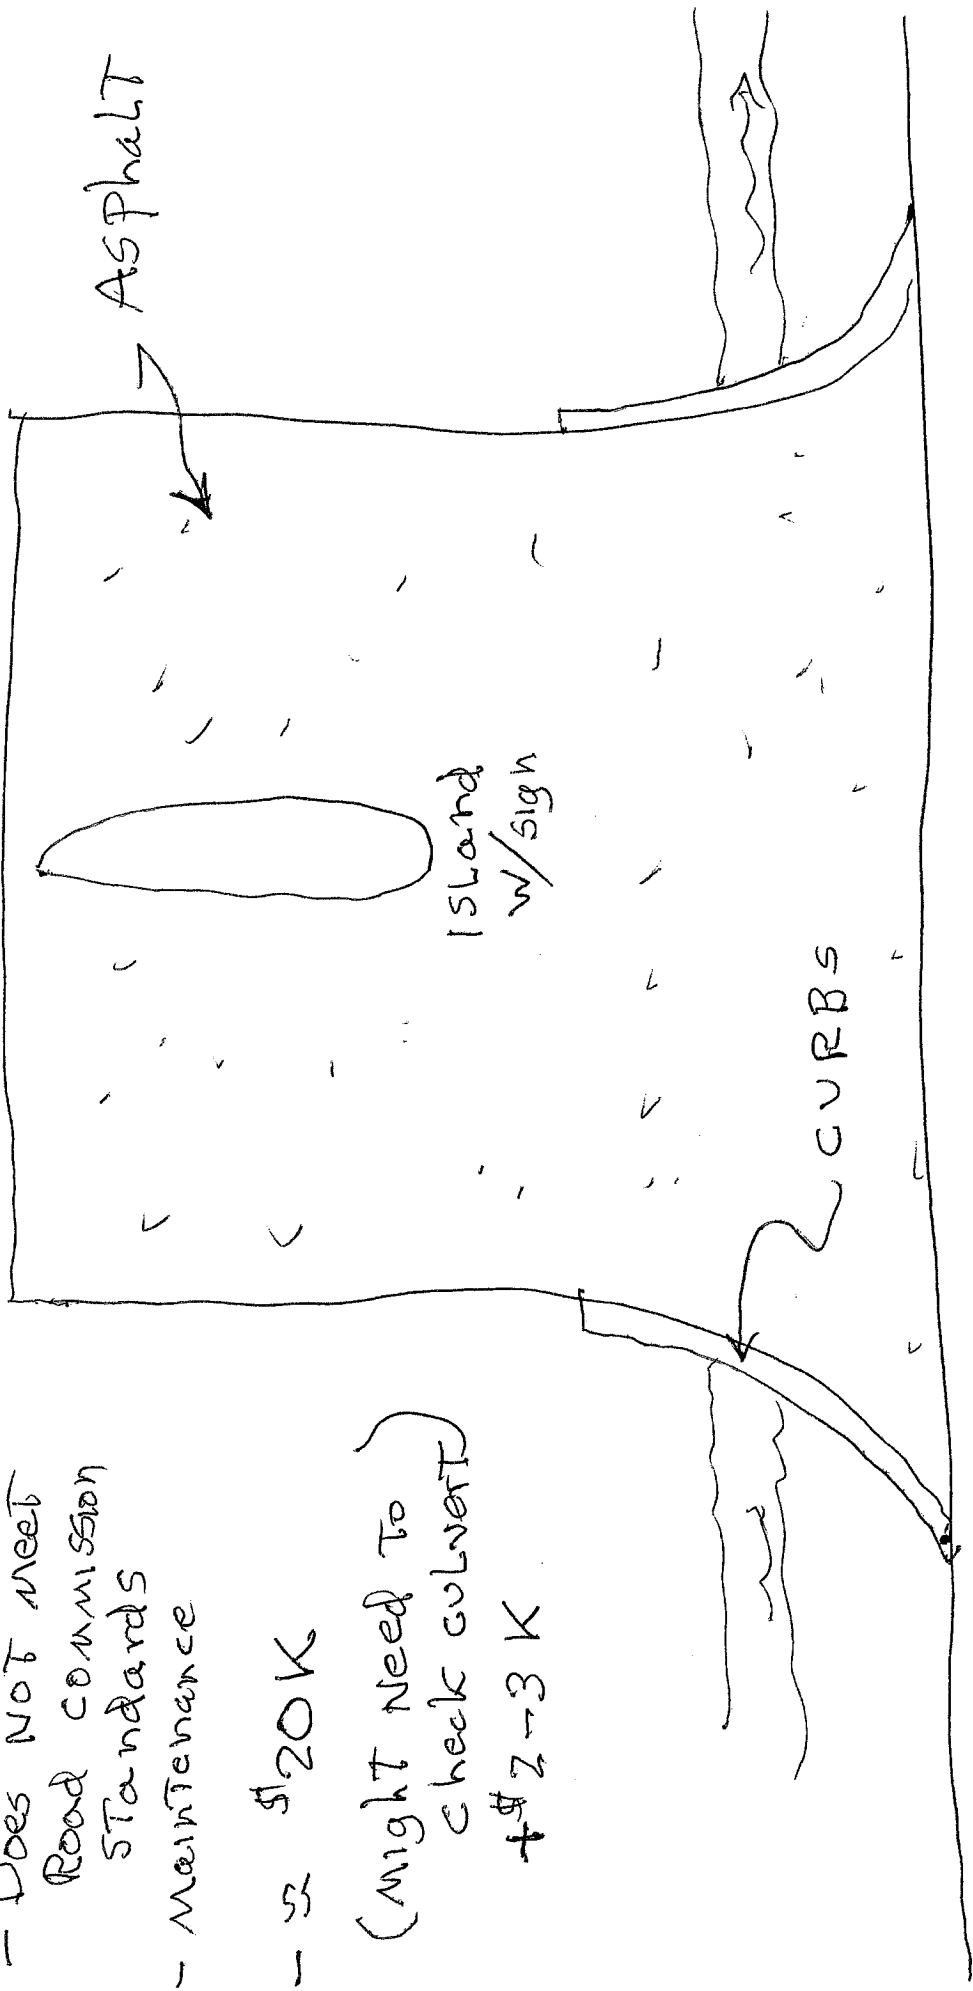
641

- Stones on Road

- Dangerous

- Does NOT meet  
Road Commission  
Standards

(Might Need to  
check culvert)

- Maintenance

- \$ 20K

+ \$ 2-3 K
