LELAND DAM INSPECTION

Dam Identification No.: 510
Hazard Potential: High
NE Quarter of Section 9, T. 30 N. – R.12 W
Leelanau County, Michigan
Lake Leelanau

Date of Inspection: September 1, 2022
Date of Report: October 2022

Project I.D. Number 131999SG2022

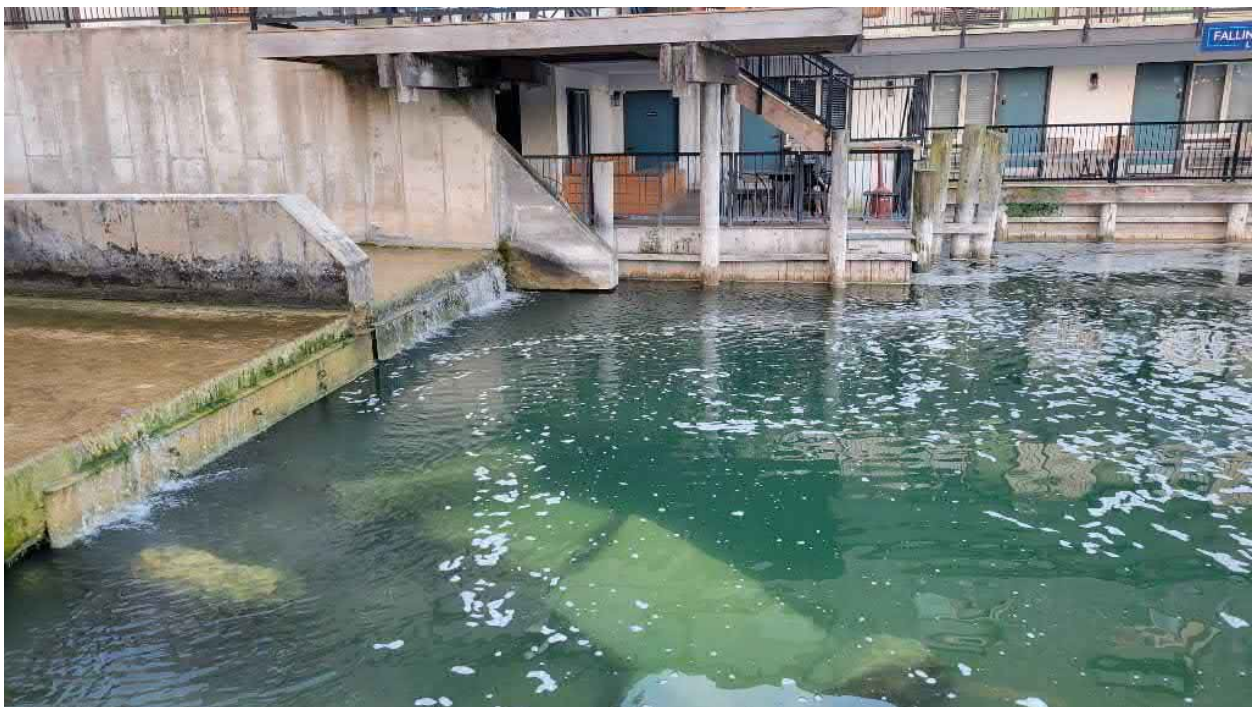
Spillway Observation While Gates are Closed

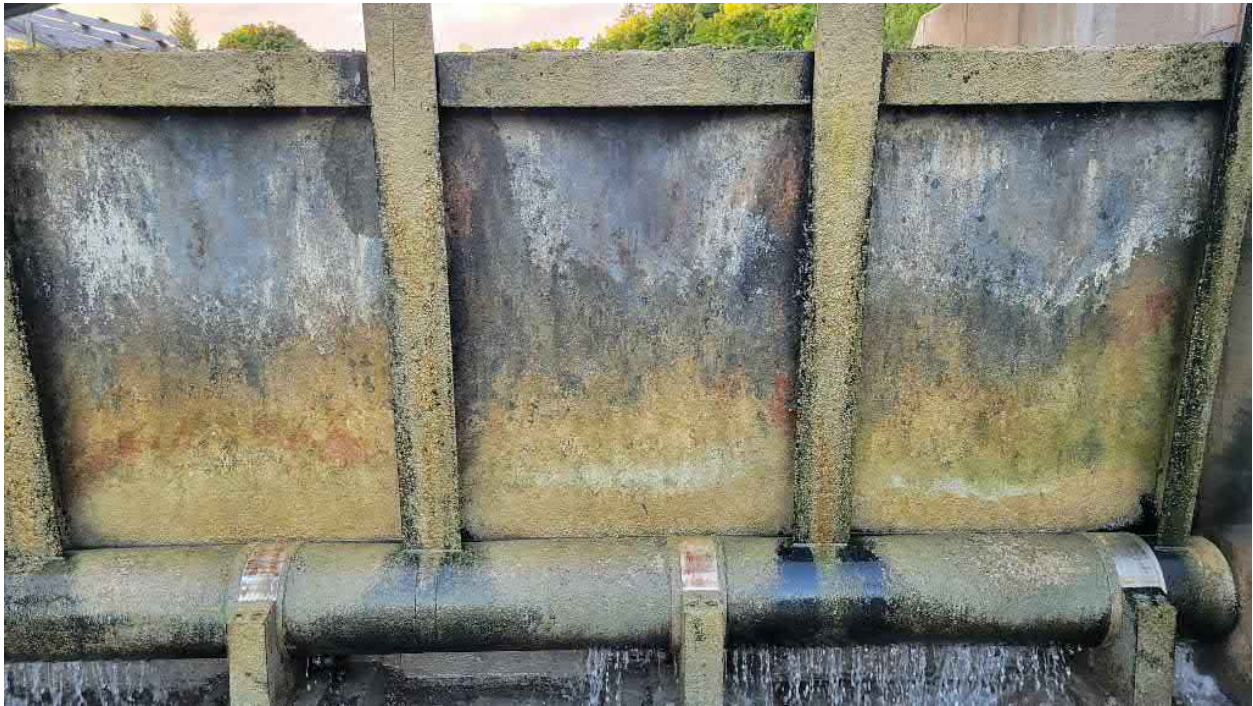
Gate Observations - Downstream Face (Closed Position)

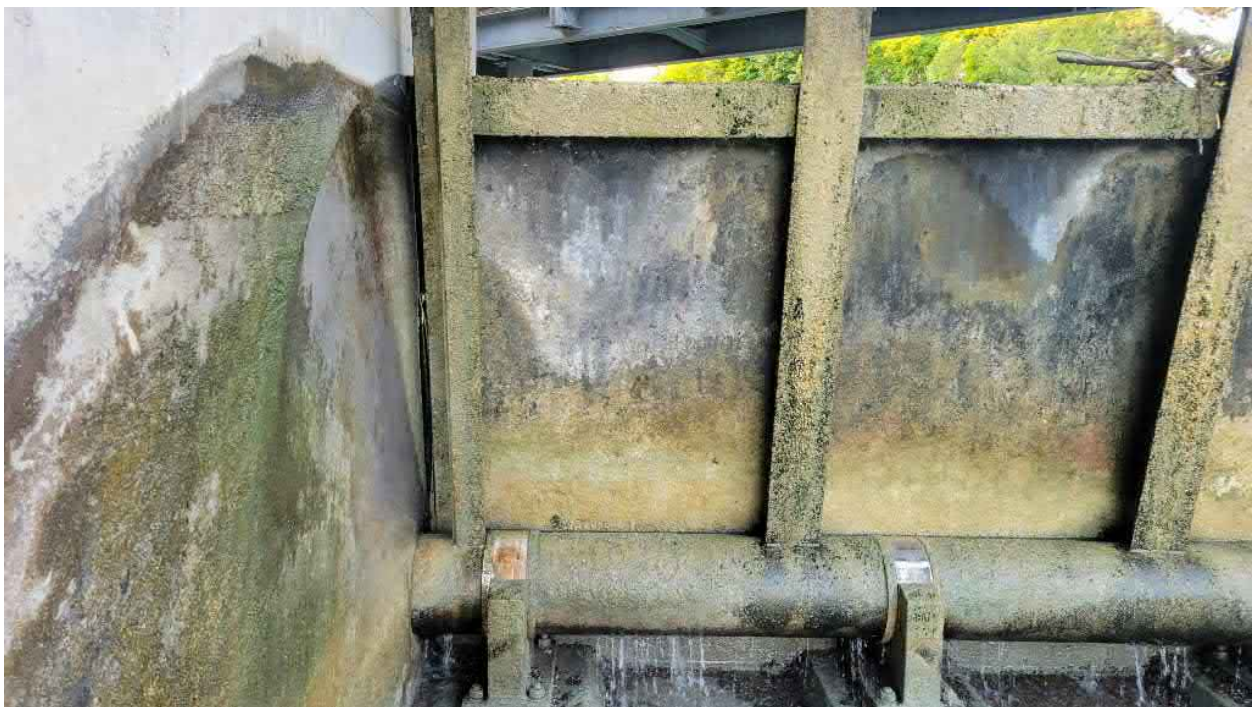
Gate Observations - Right Wall and Joints (Closed Position)

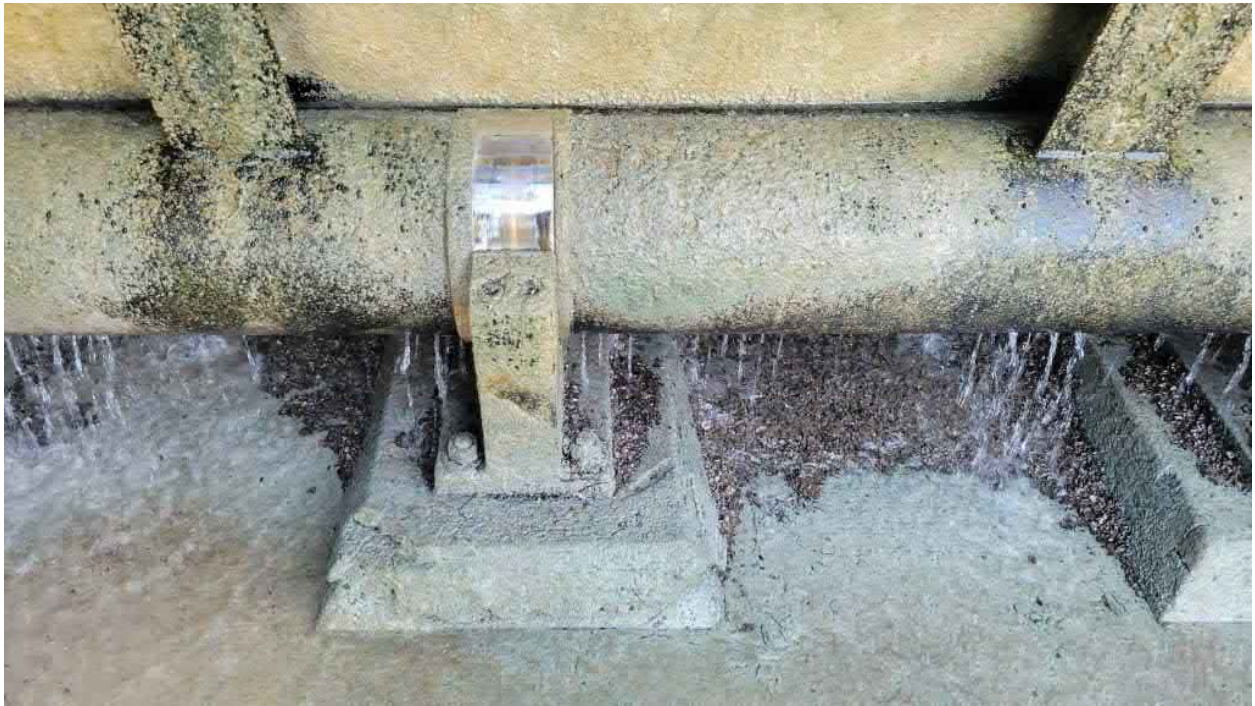
Joint Observation

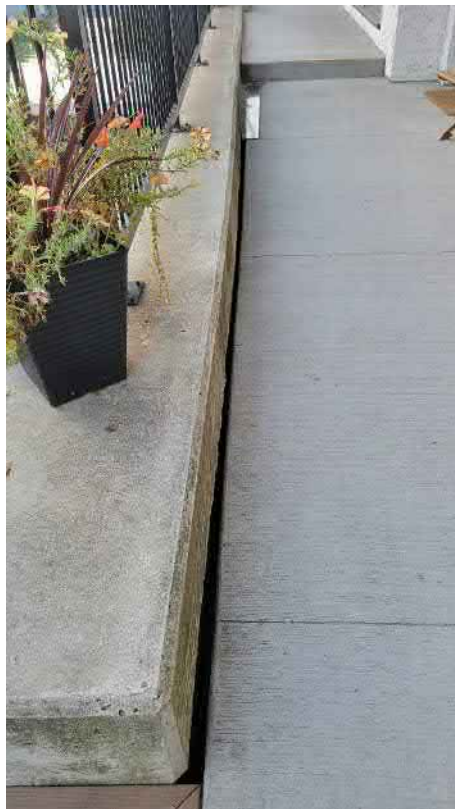
Gap between Sidewalk and Left Abutment Wall

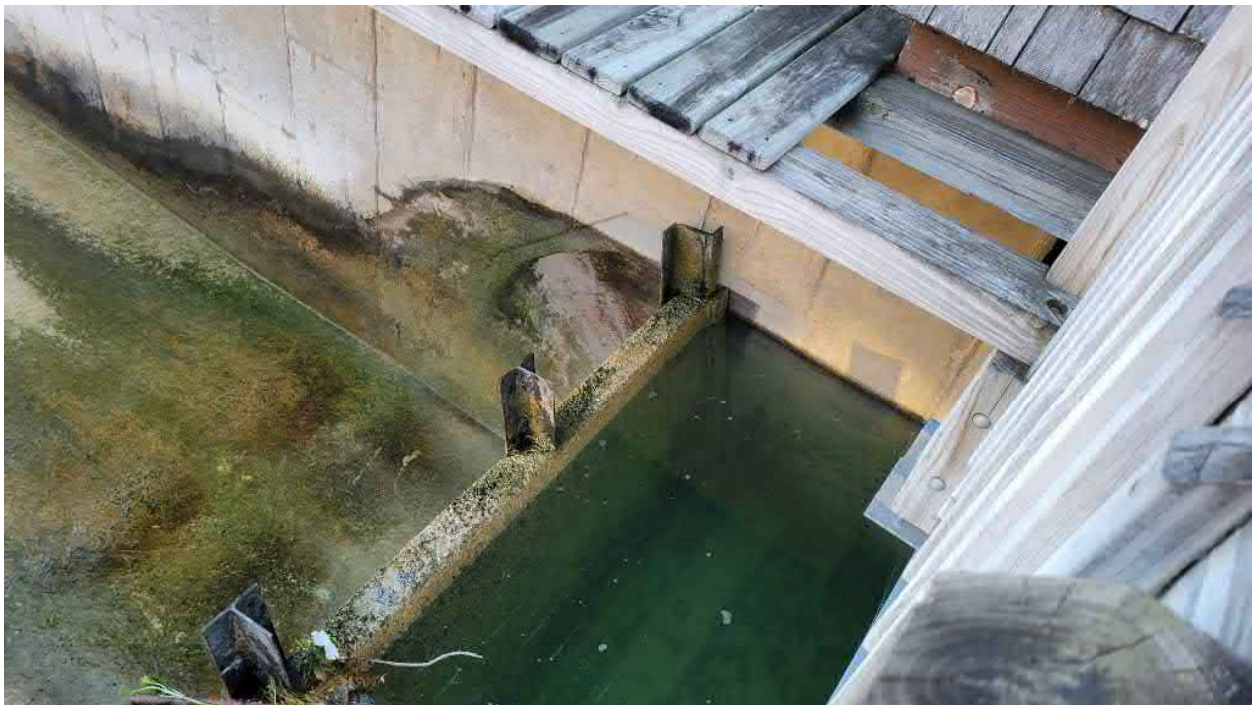
Closed Hydraulic Gate (Right Side)

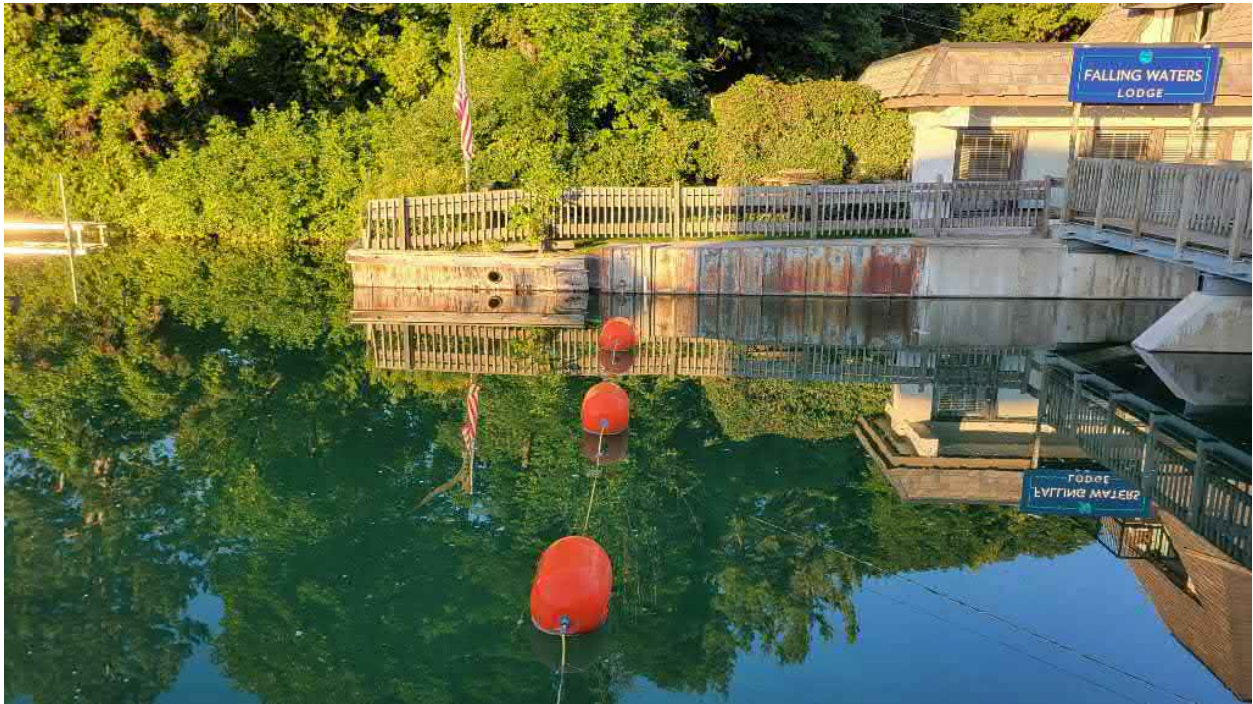
Upstream Buoys and Left Abutment Wall

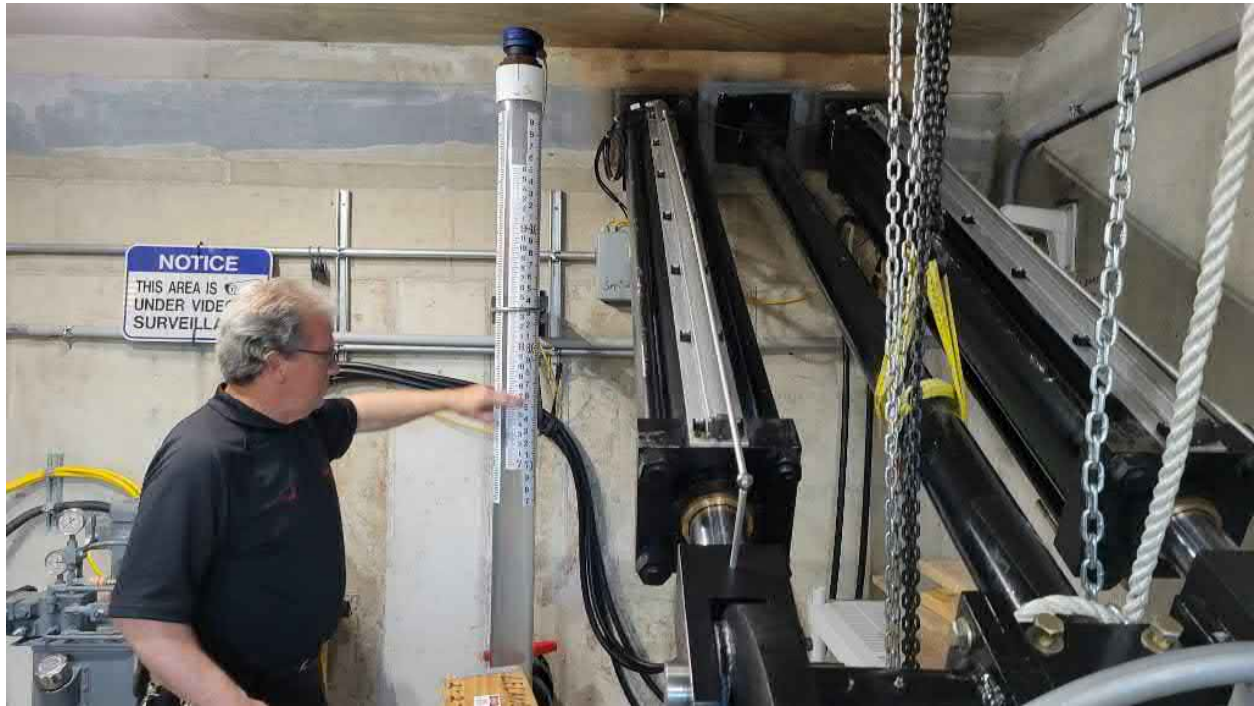
Control Room

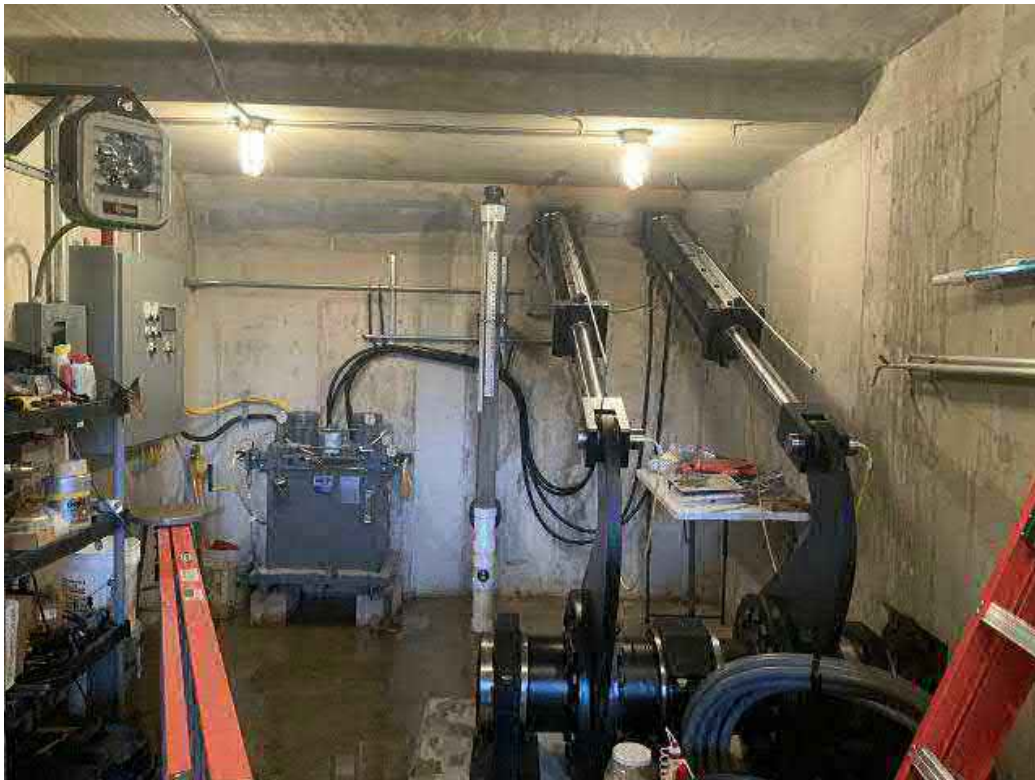
Looking southeast within hydraulics / control room at hydraulic gate actuators.

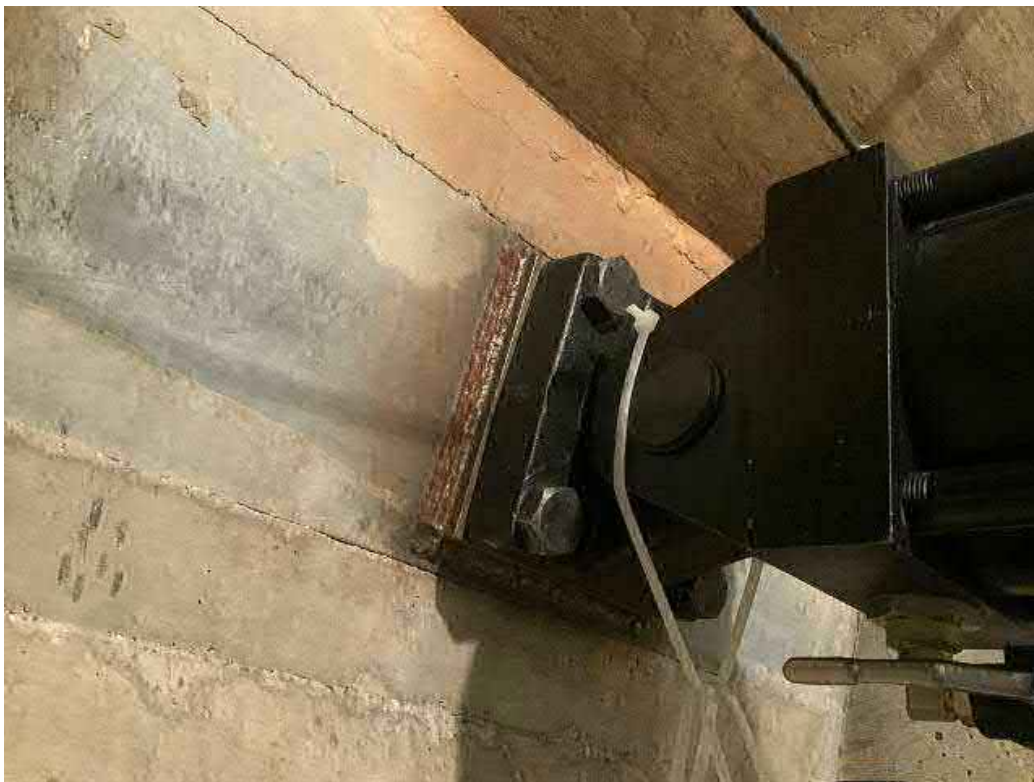
Hydraulic ram mounts to steel I-beam at ceiling / wall corner (typical of 2).

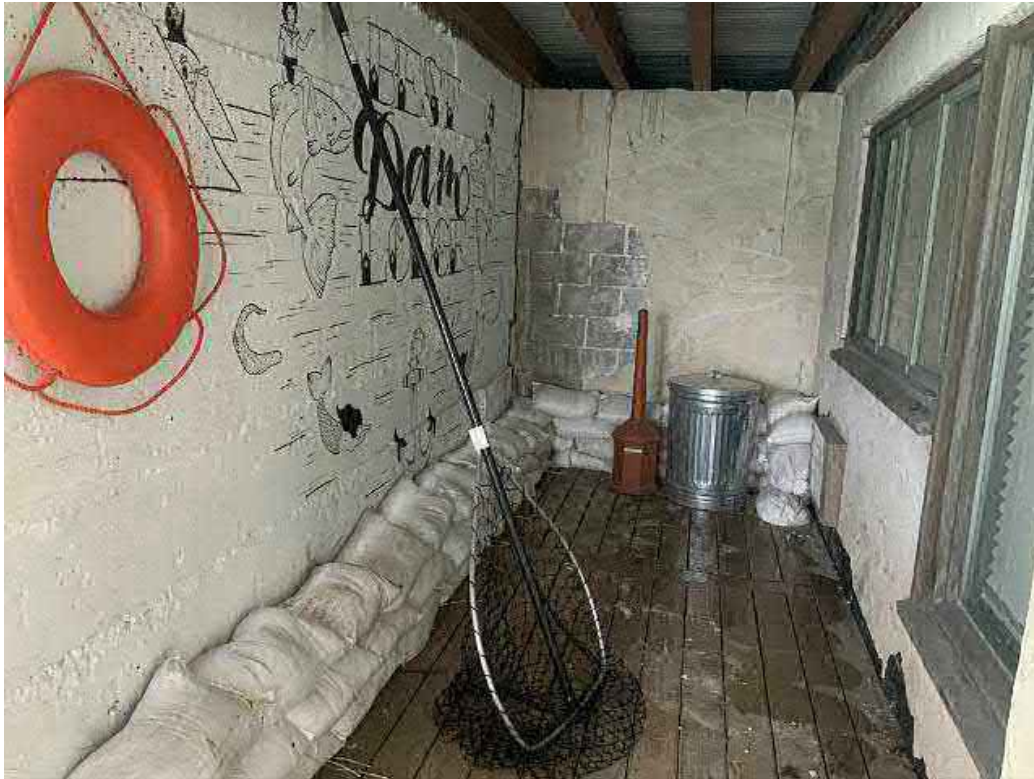
Looking southeast at outside of Bay #1 left abutment wall.

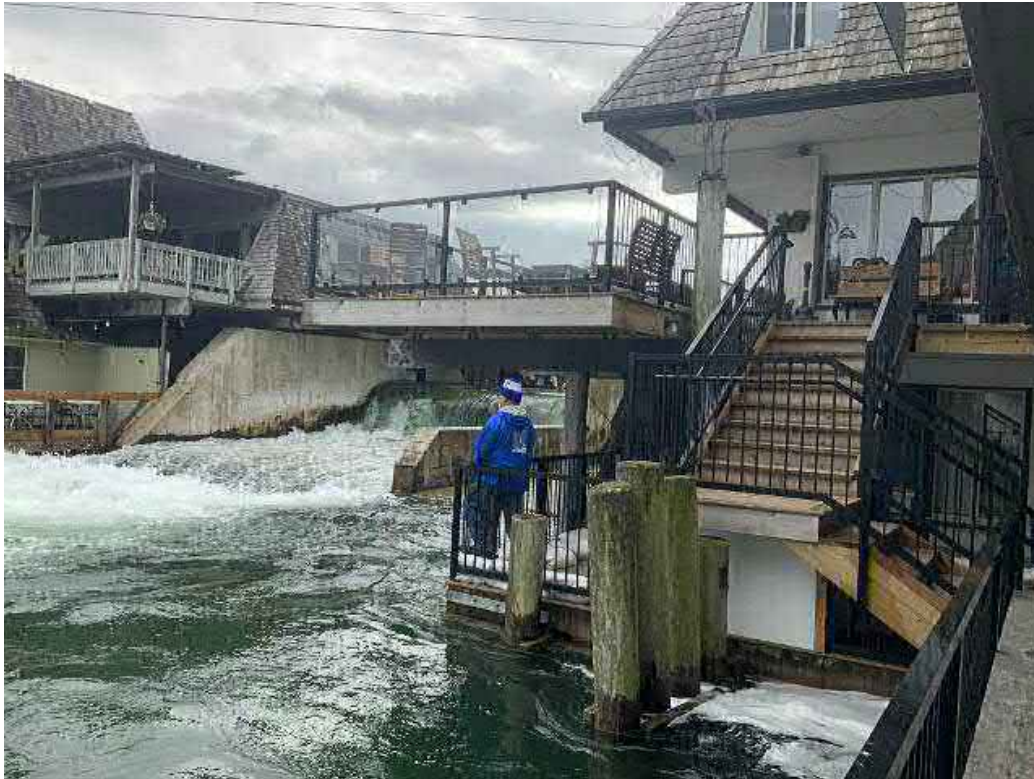
Looking east across at downstream side of dam.

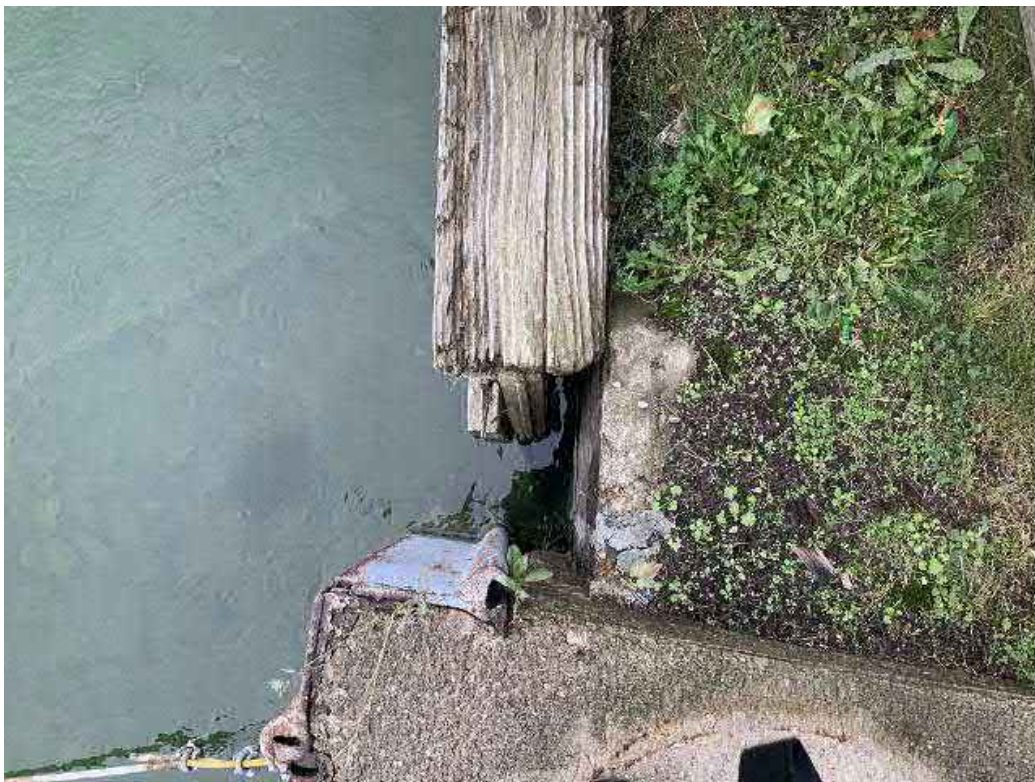
Left approach abutment wall upper end at northwest end of wood seawall.

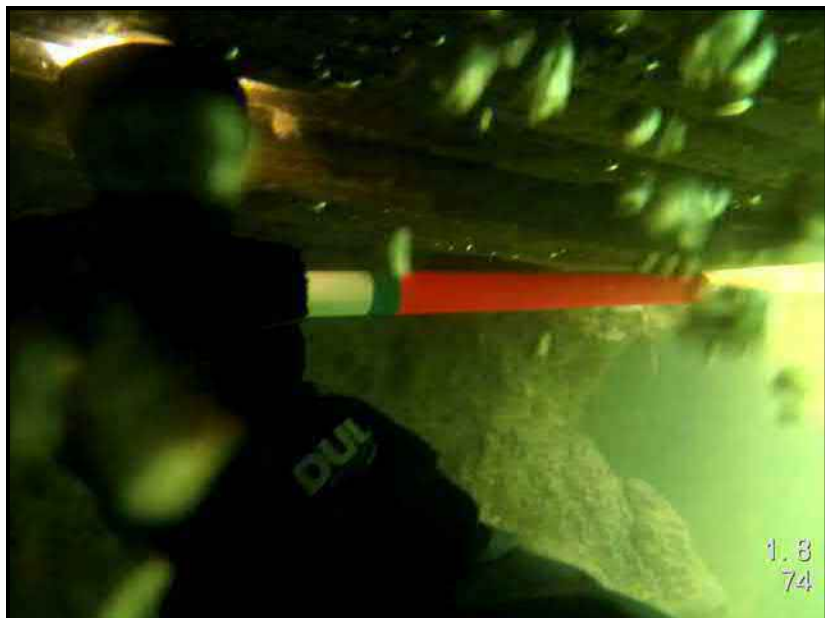
*Undermined
cutoff wall in
bay 3*
